10. A slope stability problem in Hong Kong

Introduction

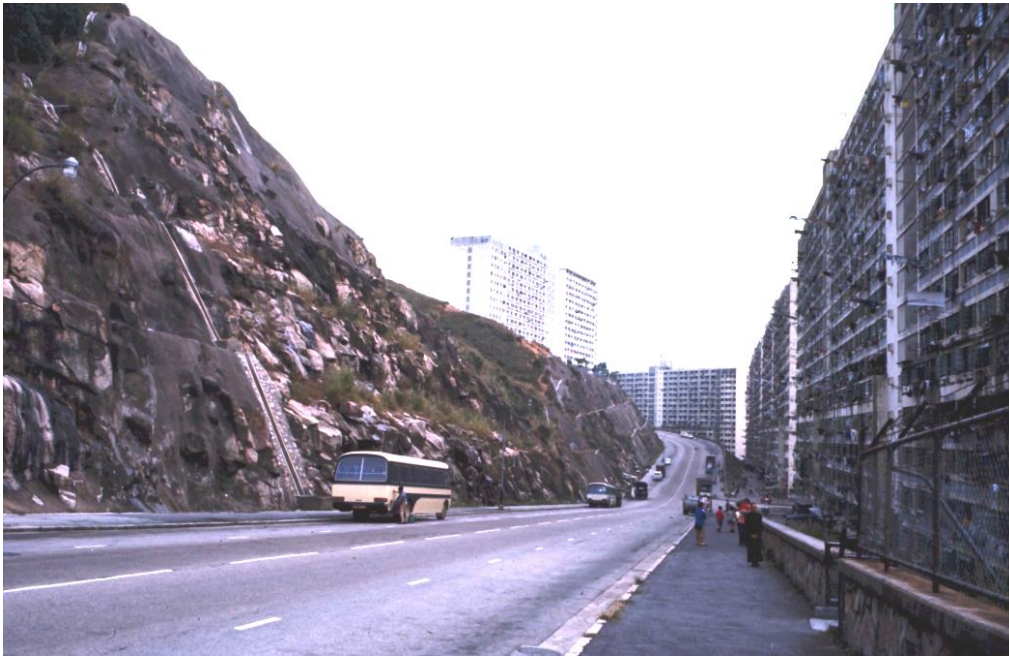
Figure 1 gives a general view down Sau Mau Ping Road, showing the steep rock slopes on the left and the apartment blocks on the right.

Figure 1: A view down Sau Mau Ping Road in Kowloon showing apartment blocks across the road from the steep rock slopes.

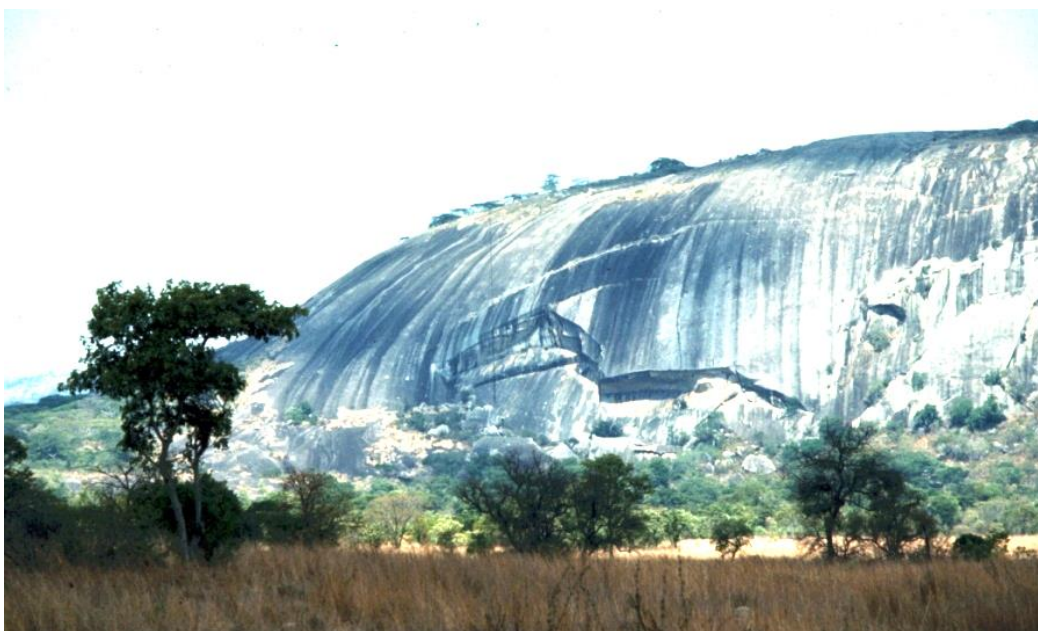
The rock mass, in which the slope adjacent to the Sau Mau Ping Road was cut, is unweathered granite with exfoliation or sheet joints similar to those illustrated in Figure 2. These joints are parallel to the surface of the granite and the spacing between successive joints increases with increasing distance into the rock mass. Undercutting of these sheet joints can cause a rock slide such as that illustrated in Figure 3.

Figure 2: Sheet jointing in granite. These features, sometimes referred to as 'onion skin' joints, are the result of exfoliation processes during cooling of the granite.

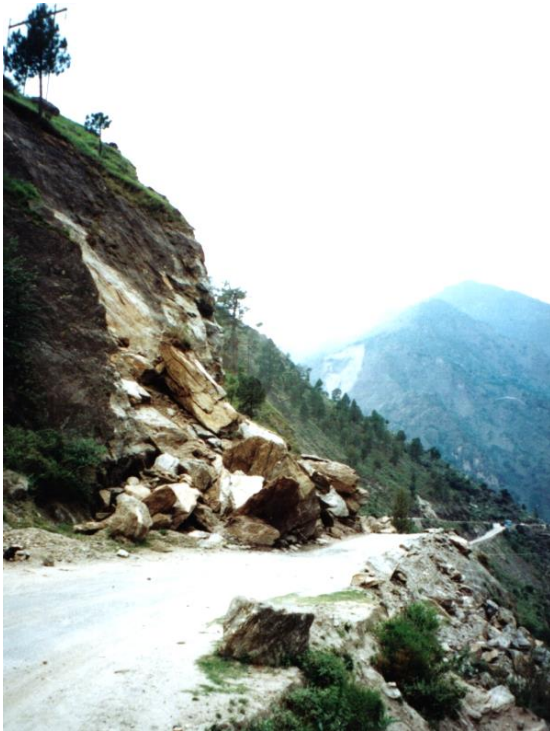
Figure 3: A rockslide on a road caused by the undercutting of sheet joints in a granite slope. In hard rocks such as granite, failure can occur very suddenly if the factor of safety of the slope is close to 1. A rise in groundwater levels during a heavy storm or ice jacking in winter may be sufficient to induce failure.

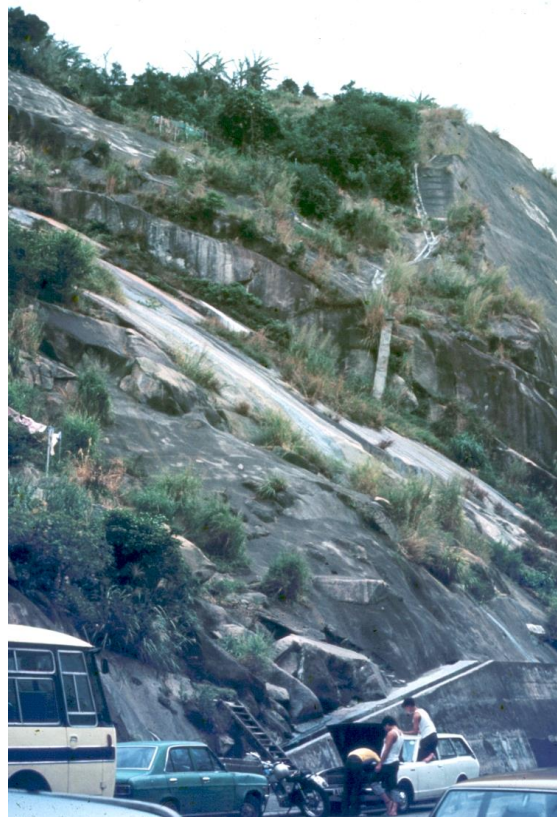
During excavation of the original slopes for the Sau Mau Ping Road, a small rock slide was induced by blasting. The surface on which this failure occurred is illustrated in Figure 4. Blasting, such as that used in civil construction in an urban environment, does not impose very large loads on rock slopes and it can be assumed that the factor of safety of the slope was close to unity.

Figure 4: The failure surface defined by a sheet joint surface on which a small slide occurred during blasting of the original cut slope for the Sau Mau Ping Road. The potentially unstable slope discussed is visible in the background.

The potentially unstable slope under consideration is visible in the background of this photograph. It is obvious from this photograph that the sheet joint surface continues under the potentially unstable slope. Hence, from the evidence of the small-scale failure, it can be deduced that the factor of safety of the slope in question is not very high.

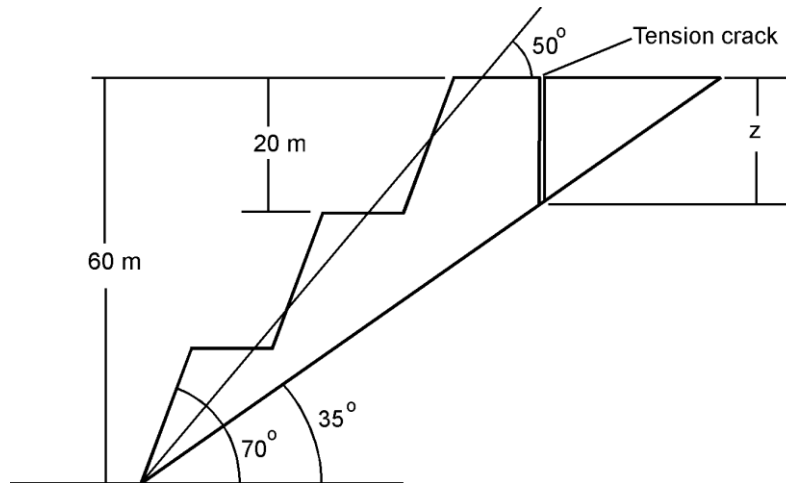
The geometry of the slope is illustrated in Figure 5 which shows a 60 m high slope with three 20 m high benches. The overall slope angle is 50° and the individual bench faces are inclined at 70° to the horizontal. An exfoliation joint surface dips at 35° and undercuts the slope as shown in the figure. The slope face strikes parallel to the underlying exfoliation surface, and hence, the slope can be analysed by means of a two-dimensional model.

Tension cracks are frequently observed behind the crest of slopes which have a factor of safety of less than about 1.2. These cracks are dangerous in that they allow water to enter the slope at a particularly critical location. Unfortunately, in the case of the Sau Mau Ping slope, recently cultivated market gardens located on the top of the slope made it impossible to determine whether or not such tension cracks were present and hence it was decided to carry out two sets of analyses - one with and one without tension cracks. These analyses were carried out for both the overall slope and for individual benches.

Figure 5: Geometry assumed for the two-dimensional analysis of the Sau Mau Ping Road slope.

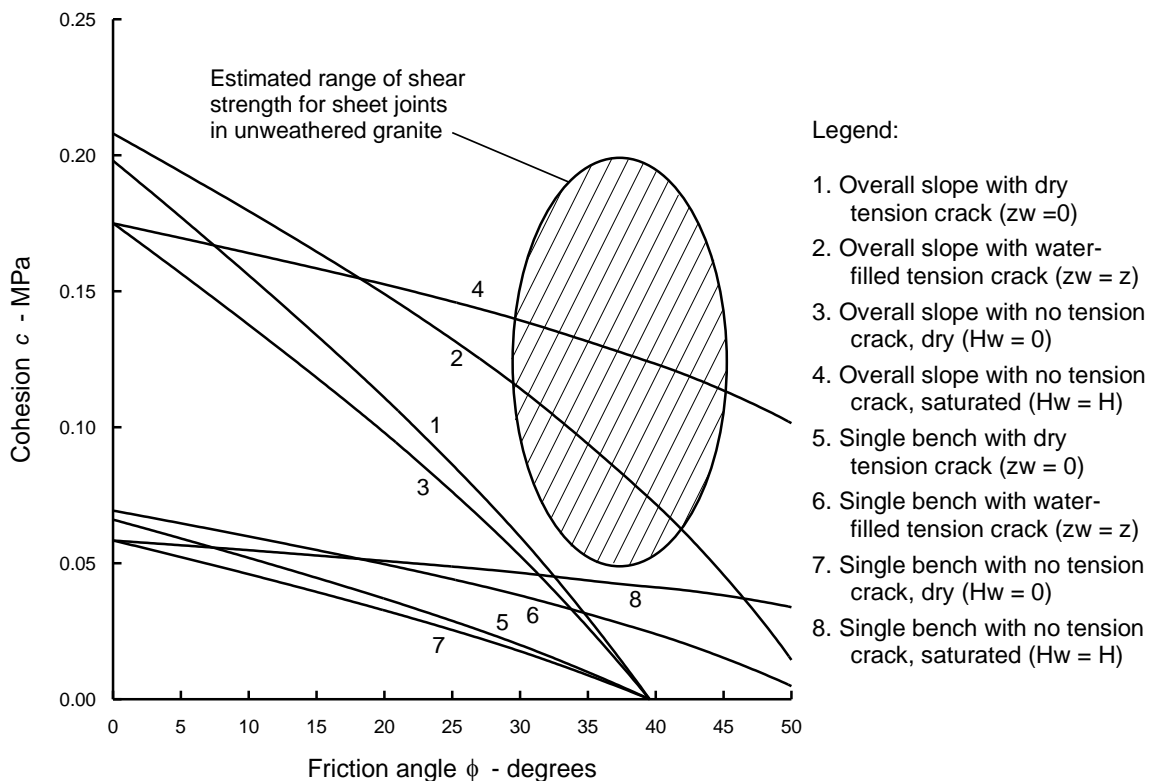
One method for assessing the stability of slopes is to calculate the shear strength that would be mobilised at failure and to compare this strength with the shear strength which is available along the failure surface. In the case of the Sau Mau Ping slope, this was done by substituting $F = 1$ in equations 1 and 5 and solving for the cohesive strength c and the friction angle ϕ . The results of this analysis are plotted in Figure 9. The estimated range of available shear strength (from Figure 8) is also shown on this plot.

Figure 9 shows that only two of the cases analysed result in conditions where the shear strength mobilised at failure falls within the estimated range of available shear strength. These two cases are designated 2 and 4 and they are for fully saturated slopes, with and without tension cracks.

From the results of the sensitivity study described above, it was concluded that instability of this particular slope could occur if the slope was fully saturated and subjected to earthquake loading. Typhoons occur several times every year in Hong Kong and the intensity of precipitation during these events is certainly sufficient to saturate the slopes. As discussed earlier, minor earthquakes do occur in the region, but they are not very frequent. Consequently, the chance of simultaneous saturation and earthquake loading was considered to be small and it was concluded that there was no serious short-term threat of instability of the Sau Mau Ping Slope.

Figure 9: Comparison of the shear strength mobilised by failure under various conditions with the estimated shear strength available on sheet joints in unweathered granite.

- No evacuation of the residents of the two apartment blocks, located across the street from the slope in question, would be carried out.
- Horizontal drainage holes would be drilled into the slope face to penetrate the potential failure surface to reduce uplift pressures in the slope.
- Piezometers would be installed in holes drilled from the top of the slope. These piezometers would be measured regularly during periods of significant rainfall and the road would be closed to traffic if water rose to levels decided by the engineers responsible for the project.
- An investigation would be carried out into the most effective remedial measures to stabilise the slope for the long-term.

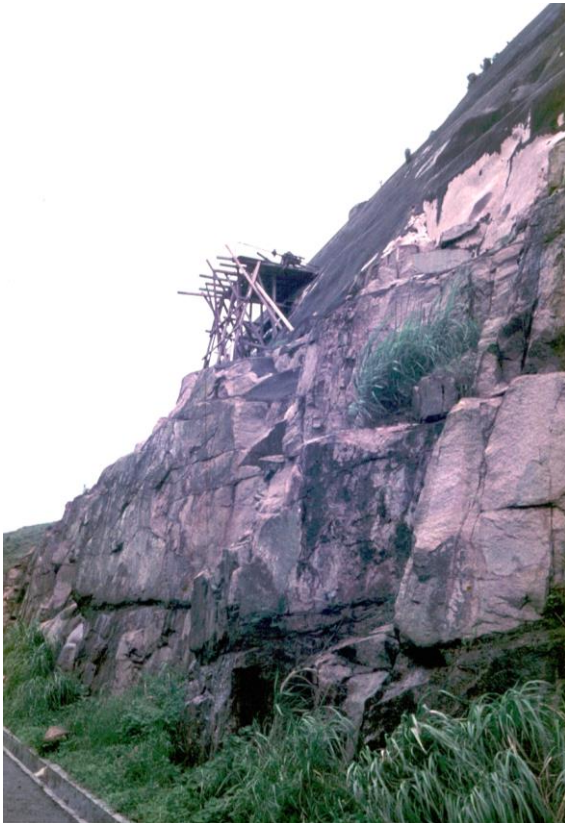
Figure 10: Drilling horizontal drain holes into the face of one of the benches of the Sau Mau Ping slope.

Figure 10 shows the drilling of the horizontal drain holes into the slope face and Figure 11 shows the drilling of the vertical holes into which the piezometers were installed. These piezometers were monitored for the next few years, while preparations for the final stabilisation of the slope were made. The road was closed to traffic on two occasions when water levels were dangerously high.

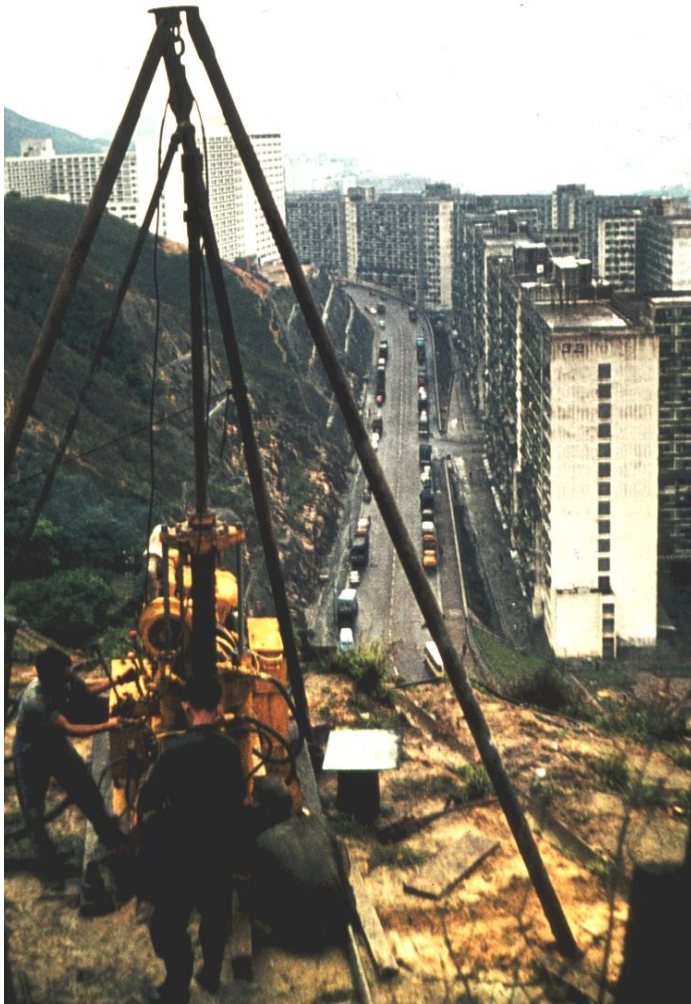
Figure 11: Drilling vertical diamond core holes into the Sau Mau Ping slope. These holes were used for geotechnical investigation purposes and for the installation of piezometers in the rock mass.

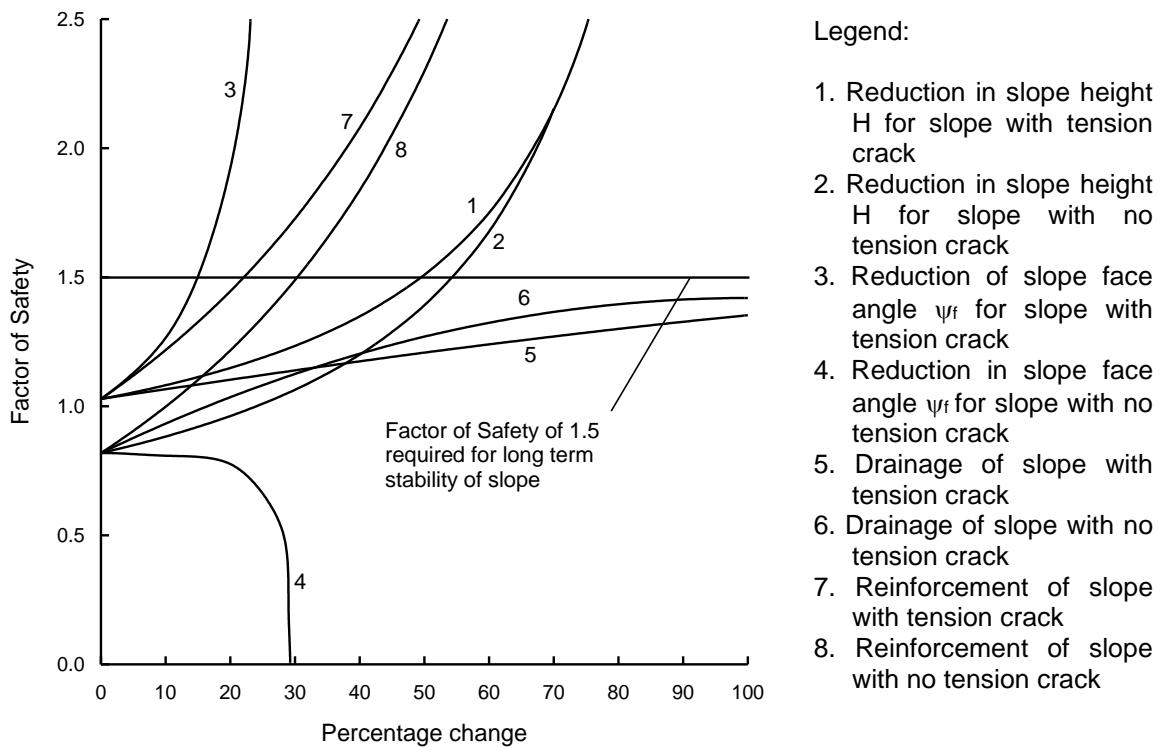
Figure 12: Evaluation of remedial options to increase the stability of the slope.

Curves 1 (slope with tension crack) and 2 (slope without tension crack) show that reduction of the slope height is not an effective solution to the problem. In order to achieve the required factor of safety of 1.5, the slope height would have to be reduced by 50%. If this solution were to be adopted, it would be more practical to excavate the entire slope since most of the volume of the rock to be excavated is contained in the upper half of the slope.

Curve 3 (slope with tension crack) shows that reduction of the slope angle is a very effective remedial measure. The required factor of safety of 1.5 is achieved for a reduction of less than 25% of the slope angle. In other words, a reduction of the overall slope face angle from 50° to 37.5° would achieve the desired result. This finding is generally true that a reduction in the face angle of a slope is usually an effective remedial step. In the case of slopes under construction, using a flatter slope is always one of the prime choices for achieving greater stability.

Curve 4 (slope without tension crack) is an anomaly. It demonstrates that calculations can sometimes produce nonsense. The reduction in factor of safety shown by this curve is a result of the reduction in the weight of the sliding block as the face angle is reduced. Since the water pressure on the sliding surface remains constant, the effective stress acting on the sliding surface decreases, and hence, the frictional component of the resisting forces decreases. When a very thin sliver of rock remains, the water pressure will float it off the slope. The problem with this analysis lies in the assumption that the block is completely impermeable and that the water remains trapped beneath the failure surface. In fact, the block would break up long before it floated and hence the water pressure acting on the failure plane would be dissipated.

Curves 5 and 6 show that drainage is not a very effective option for either of the slope models considered. In neither case is a factor of safety of 1.5 achieved. This is something of a surprise since drainage is usually one of the most effective and economical remedial measures. The reasons for the poor performance of drainage in this case is due to the combination of the geometry of the slope and the shear strength of the failure surface.

Curves 7 and 8 show that, for both slope models considered, slope reinforcement by means of rockbolts or cables can be an effective remedial measure. The anchor force required for a factor of safety of 1.5 would be about 100 tonnes per metre of slope length for the slope with no tension crack.

The two most attractive options for long term remedial works on this slope are reinforcement by means of cables or bolts or reduction of the slope face angle. The first option was finally rejected because of the high cost and because of the uncertainty about the long-term corrosion resistance of reinforcement which could be placed in the slope.

The option finally chosen was to reduce the slope face angle down to 35° by excavating the entire block resting on the failure surface, and hence, removing the problem entirely. Since good quality aggregate is always required in Hong Kong, it was decided to work this slope face as a quarry. It took several years to organise this activity and, during this time, the water levels in the slope were monitored by means of piezometers. Although the road was closed twice during this period, no major problems occurred, and the slope was finally excavated back to the failure plane.
