Introduction

During this review, a rock slope on Sau Mau Ping Road in Kowloon was identified as being potentially unstable. The stability of this particular slope was critical because it was located immediately across the road from two blocks of apartments, each housing approximately 5,000 people.

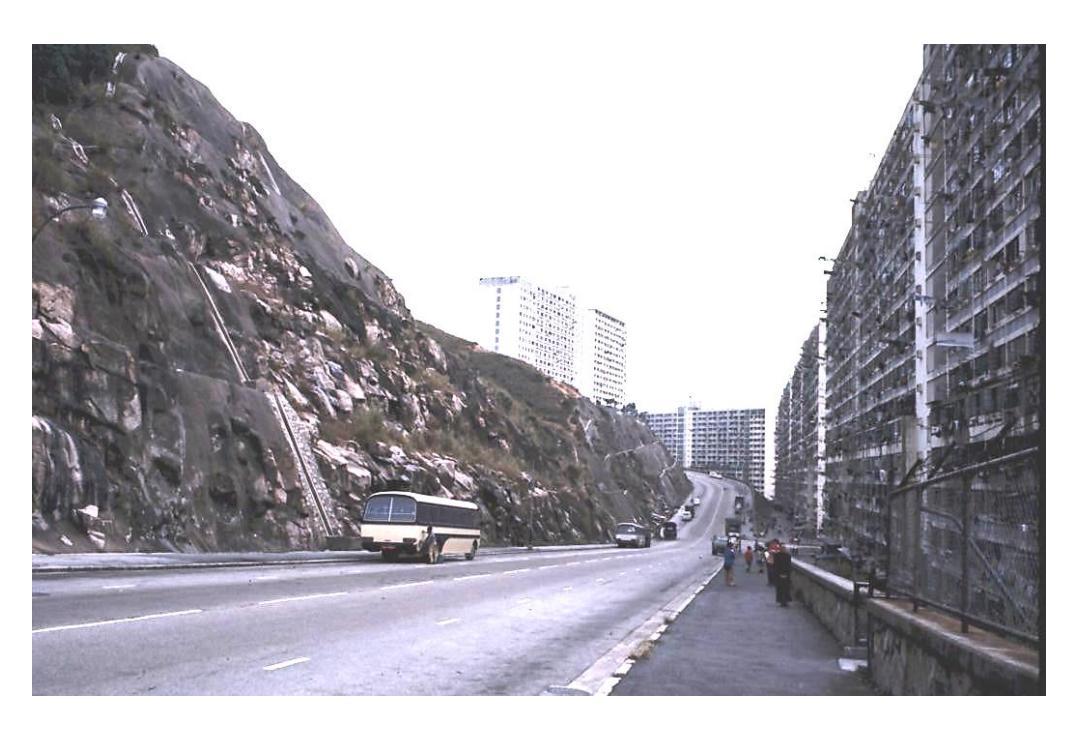
Figure 1: A view down Sau Mau Ping Road in Kowloon showing apartment blocks across the road from the steep rock slopes.

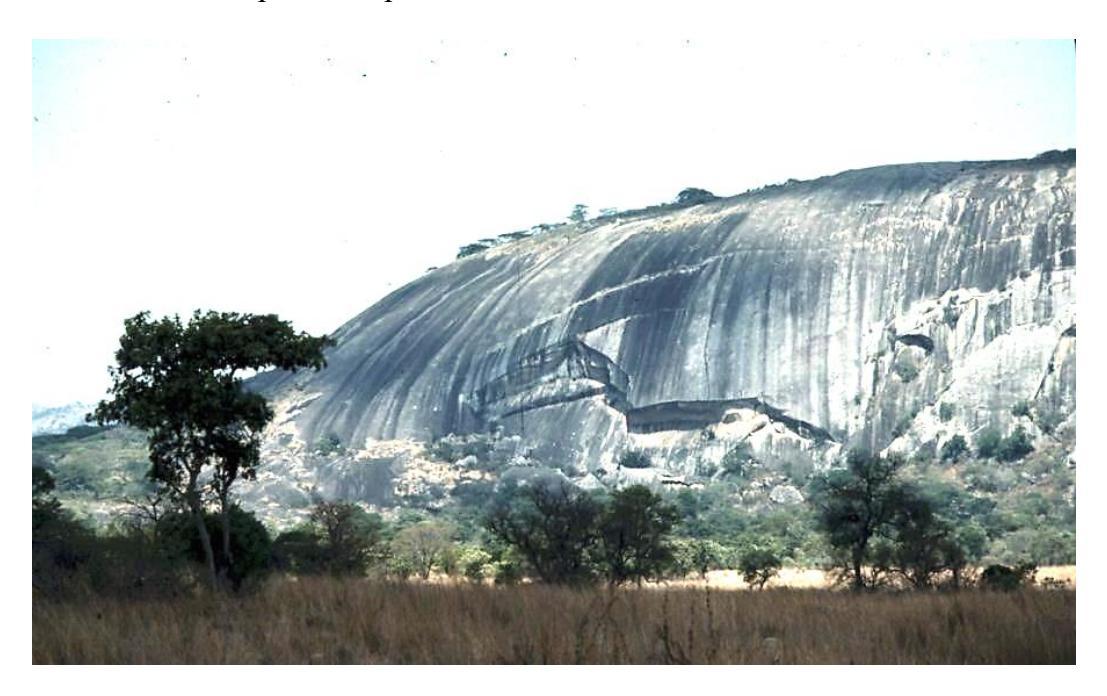
The rock mass in which the slope adjacent to the Sau Mau Ping Road was cut is unweathered granite with exfoliation or sheet joints similar to those illustrated in Figure 2. These joints are parallel to the surface of the granite and the spacing between successive joints increases with increasing distance into the rock mass. Undercutting of these sheet joints can cause a rock slide such as that illustrated in Figure 3.

Figure 2: Sheet jointing in granite. These features, sometimes referred to as 'onion skin' joints, are the result of exfoliation processes during cooling of the granite.

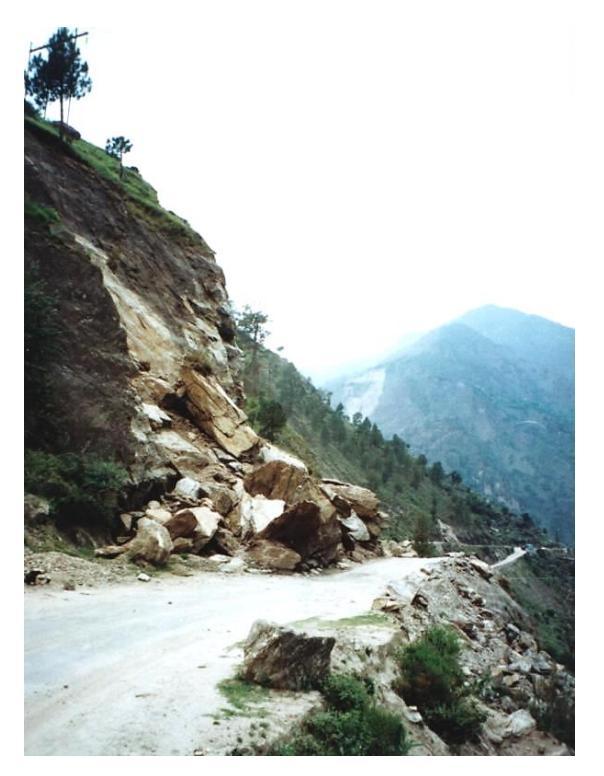
Figure 3: A rock slide on a road caused by the undercutting of sheet joints in a granite slope. In hard rocks such as granite, failure can occur very suddenly if the factor of safety of the slope is close to 1. A rise in groundwater levels during a heavy storm or ice jacking in winter may be sufficient to induce failure.

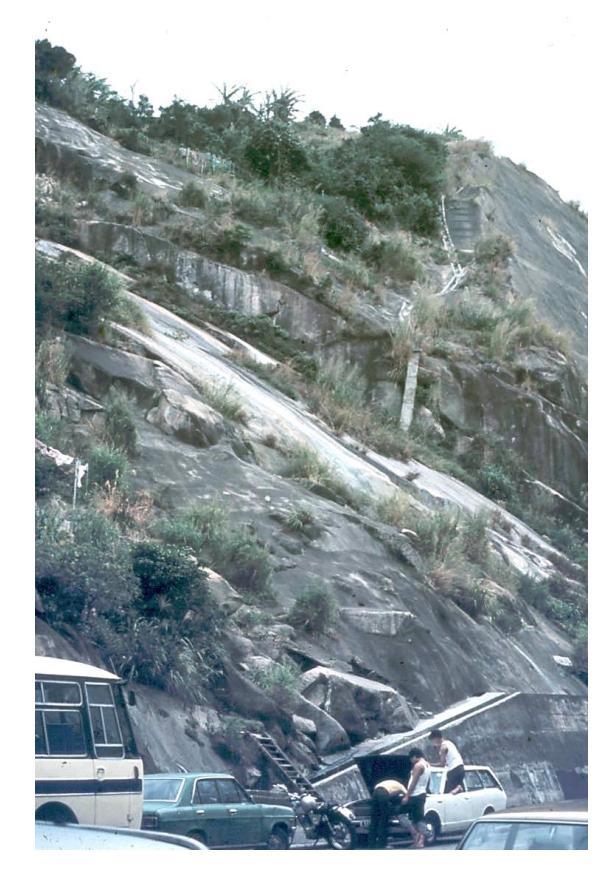
During excavation of the original slopes for the Sau Mau Ping Road, a small rock slide was induced by blasting. The surface on which this failure occurred is illustrated in Figure 4. Blasting, such as that used in civil construction in an urban environment, does not impose very large loads on rock slopes and it can be assumed that the factor of safety of the slope was close to unity.

Figure 4: The failure surface defined by a sheet joint surface on which a small slide occurred during blasting of the original cut slope for the Sau Mau Ping Road. The potentially unstable slope under consideration is visible in the background.

The potentially unstable slope under consideration is visible in the background of this photograph. It is obvious from this photograph that the sheet joint surface continues under the potentially unstable slope. Hence, from the evidence of the small scale failure, it can be deduced that the factor of safety of the slope in question is not very high.

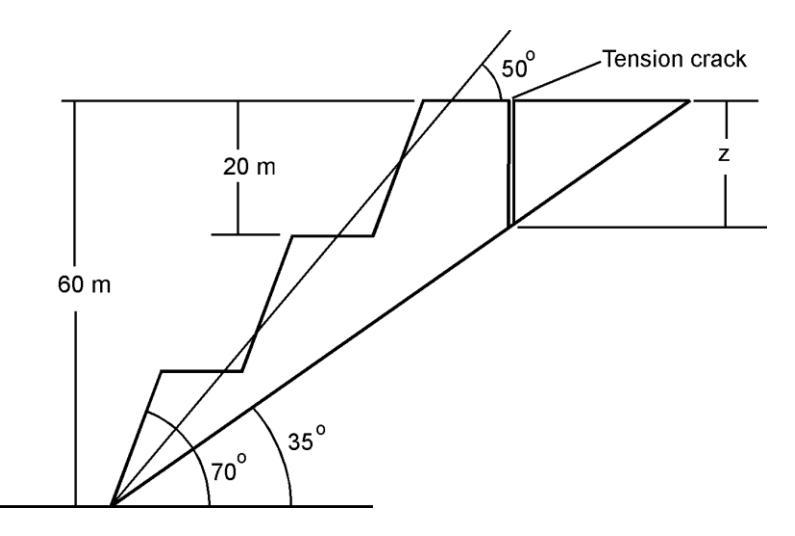
The geometry of the slope is illustrated in Figure 5 which shows a 60 m high slope with three 20 m high benches. The overall slope angle is 50° and the individual bench faces are inclined at 70° to the horizontal. An exfoliation joint surface dips at 35° and undercuts the slope as shown in the figure. The slope face strikes parallel to the underlying exfoliation surface and hence the slope can be analysed by means of a two-dimensional model.

Tension cracks are frequently observed behind the crest of slopes which have a factor of safety of less than about 1.2. These cracks are dangerous in that they allow water to enter the slope at a particularly critical location. Unfortunately, in the case of the Sau Mau Ping slope, recently cultivated market gardens located on the top of the slope made it impossible to determine whether or not such tension cracks were present and hence it was decided to carry out two sets of analyses - one with and one without tension cracks. These analyses were carried out for both the overall slope and for individual benches.

Figure 5: Geometry assumed for the two-dimensional analysis of the Sau Mau Ping Road slope.

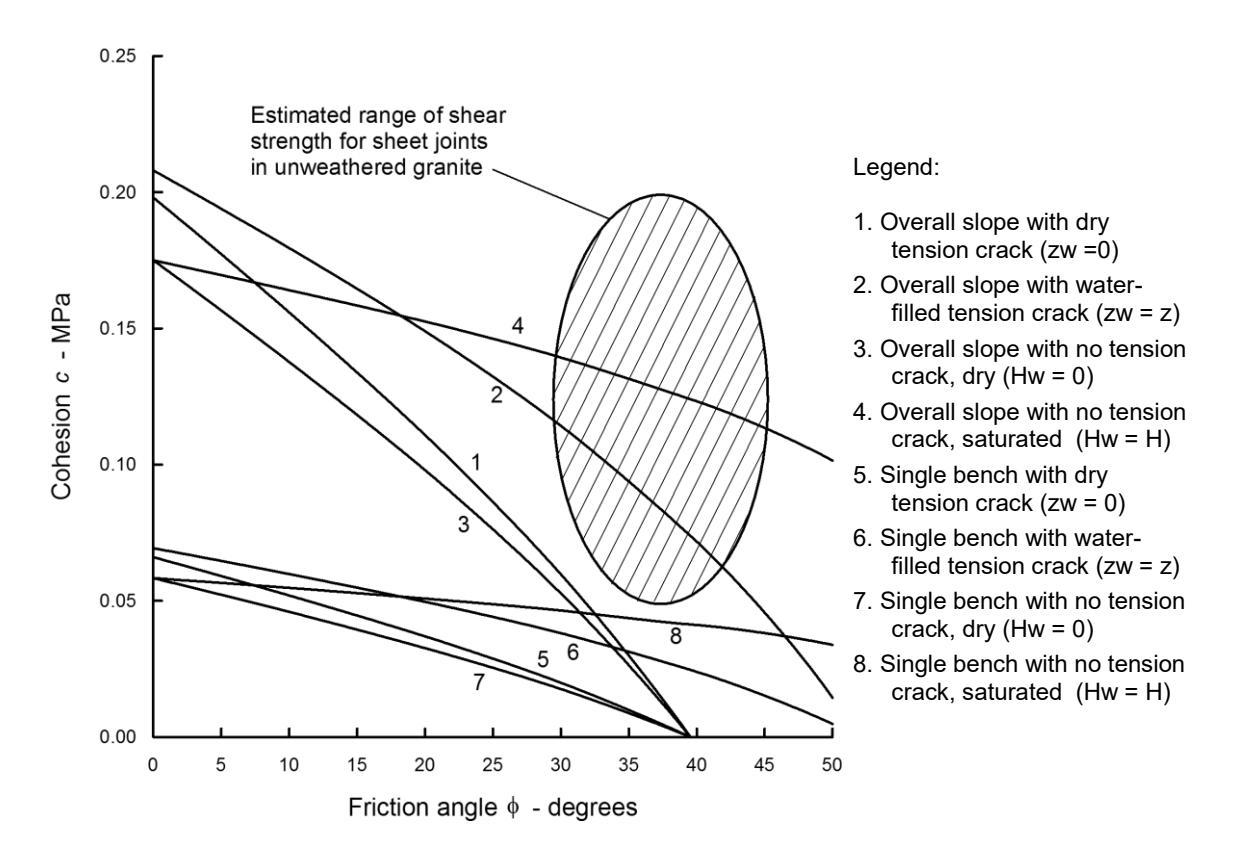
Figure 9 shows that only two of the cases analysed result in conditions where the shear strength mobilised at failure falls within the estimated range of available shear strength. These two cases are designated 2 and 4 and they are for fully saturated slopes, with and without tension cracks.

From the results of the sensitivity study described above it was concluded that instability of this particular slope could occur if the slope was fully saturated and subjected to earthquake loading. Typhoons occur several times every year in Hong Kong and the intensity of precipitation during these events is certainly sufficient to saturate the slopes. As discussed earlier, minor earthquakes do occur in the region but they are not very frequent. Consequently, the chance of simultaneous saturation and earthquake loading was considered to be small and in was concluded that there was no serious short-term threat of instability of the Sau Mau Ping slope.

Figure 9: Comparison of the shear strength mobilised by failure under various conditions with the estimated shear strength available on sheet joints in unweathered granite.

In discussion with the highway authorities in Hong Kong, the following decisions were made:

No evacuation of the residents of the two apartment blocks, located across the street from the slope in question, would be carried out.

Horizontal drainage holes would be drilled into the slope face to penetrate the potential failure surface in an attempt to reduce uplift pressures in the slope.

Piezometers would be installed in holes drilled from the top of the slope. These piezometers would be measured regularly during periods of significant rainfall and the road would be closed to traffic if water levels rose to levels decided by the engineers responsible for the project.

An investigation would be carried out into the most effective remedial measures to stabilise the slope for the long-term.

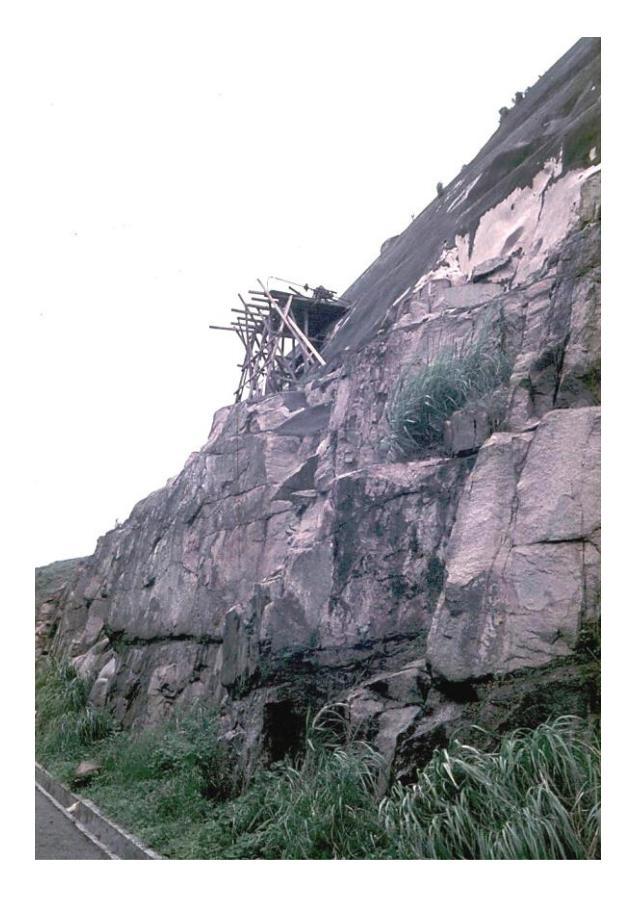
Figure 10 shows the drilling of the horizontal drain holes into the slope face and Figure 11 shows the drilling of the vertical holes into which the piezometers were installed. These piezometers were monitored for the next few years, while preparations for the final stabilisation of the slope were made, and the road was closed to traffic on two occasions when water levels were considered to be dangerously high.

Figure 10: Drilling horizontal drain holes into the face of one of the benches of the Sau Mau Ping slope.

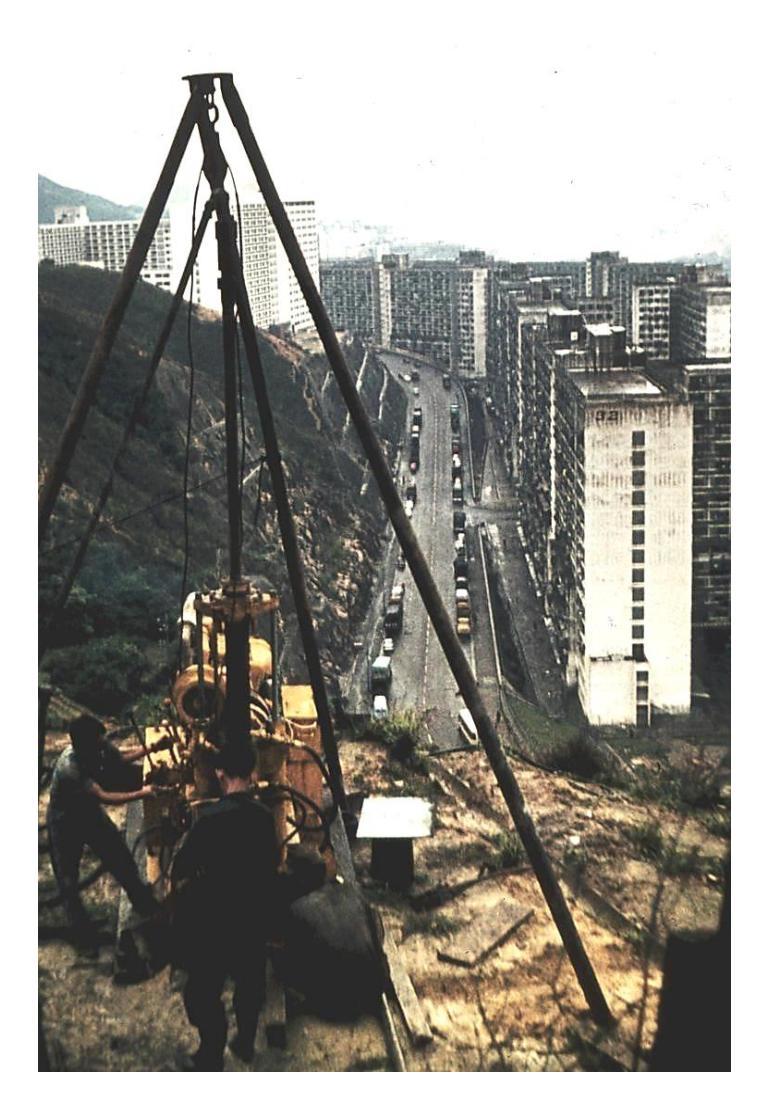
Figure 11: Drilling vertical diamond core holes into the Sau Mau Ping slope. These holes were used for geotechnical investigation purposes and also for the installation of piezometers in the rock mass.

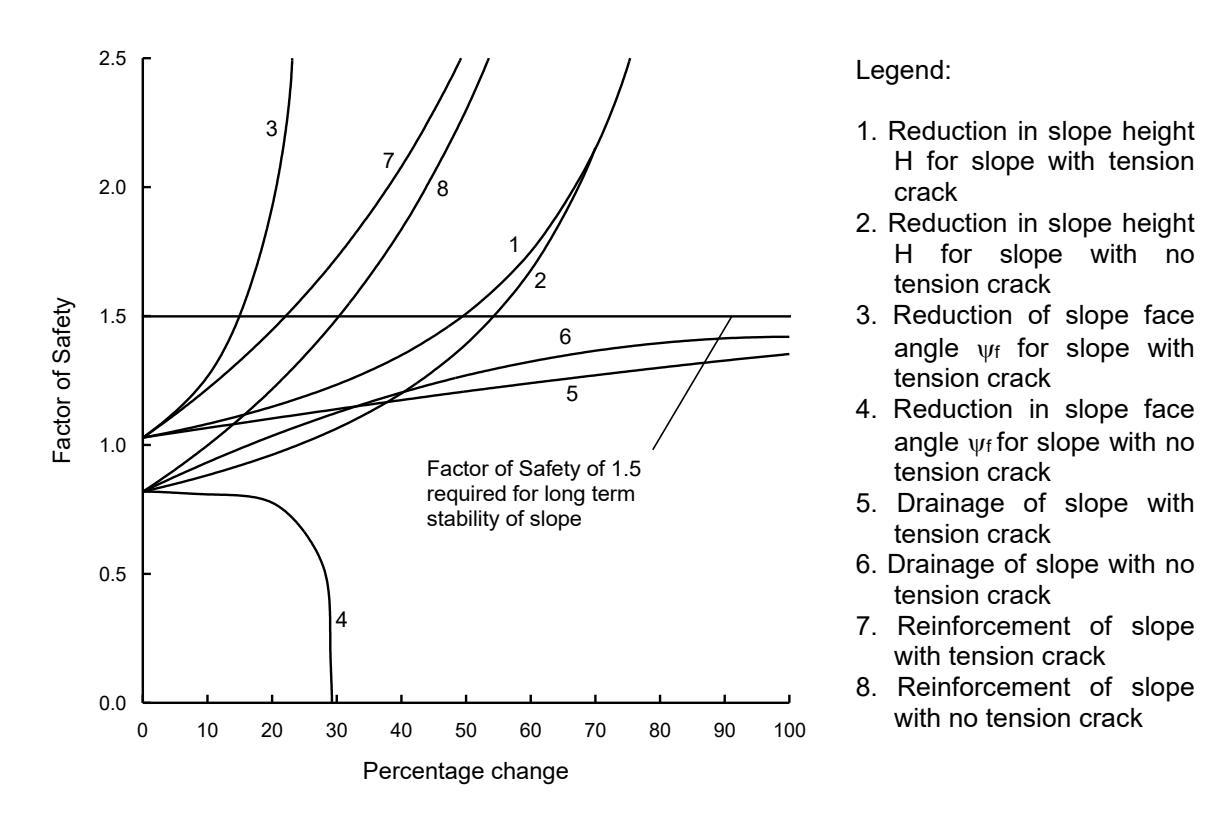
Figure 12: Evaluation of remedial options to increase the stability of the slope

Curves 1 (slope with tension crack) and 2 (slope without tension crack) show that reduction of the slope height is not an effective solution to the problem. In order to achieve the required factor of safety of 1.5, the slope height would have to be reduced by 50%. If this solution were to be adopted, it would be more practical to excavate the entire slope since most of the volume of the rock to be excavated is contained in the upper half of the slope.

Curve 3 (slope with tension crack) shows that reduction of the slope angle is a very effective remedial measure. The required factor of safety of 1.5 is achieved for a reduction of less than 25% of the slope angle. In other words, a reduction of the overall slope face angle from 50° to 37.5° would achieve the desired result. This finding is generally true and a reduction in the face angle of a slope is usually an effective remedial step. In the case of slopes under construction, using a flatter slope is always one of the prime choices for achieving greater stability.

Curve 4 (slope without tension crack) is an anomaly and demonstrates that calculations can sometimes produce nonsense. The reduction in factor of safety shown by this curve is a result of the reduction in the weight of the sliding block as the face angle is reduced. Since the water pressure on the sliding surface remains constant, the effective stress acting on the sliding surface decreases and hence the frictional component of the resisting forces decreases. When a very thin sliver of rock remains, the water pressure will float it off the slope. The problem with this analysis lies in the assumption that the block is completely impermeable and that the water remains trapped beneath the failure surface. In fact, the block would break up long before it floated and hence the water pressure acting on the failure plane would be dissipated.

Curves 5 and 6 show that drainage is not a very effective option for either of the slope models considered. In neither case is a factor of safety of 1.5 achieved. This is something of a surprise since drainage is usually one of the most effective and economical remedial measures. The reasons for the poor performance of drainage in this case is due to the combination of the geometry of the slope and the shear strength of the failure surface.

Curves 7 and 8 show that, for both slope models considered, slope reinforcement by means of rockbolts or cables can be an effective remedial measure. The anchor force required for a factor of safety of 1.5 would be about 100 tonnes per metre of slope length for the slope with no tension crack.

The option finally chosen was to reduce the slope face angle down to 35° by excavating the entire block resting on the failure surface and hence removing the problem entirely. Since good quality aggregate is always required in Hong Kong it was decided to work this slope face as a quarry. It took several years to organise this activity and, during this time, the water levels in the slope were monitored by means of piezometers. Although the road was closed twice during this period, no major problems occurred and the slope was finally excavated back to the failure plane.
