**Geological risk in the use of TBMs in heterogeneous rock masses – The case of “Metro do Porto” and the measures adopted**

Dr Siegmund Babendererde, Dr Evert Hoek, Professor Paul Marinos and Professor António Silva Cardoso

Presented at the Course on Geotechnical Risks in Rock Tunnels,  
University of Aveiro, Portugal, 16-17 April, 2004.

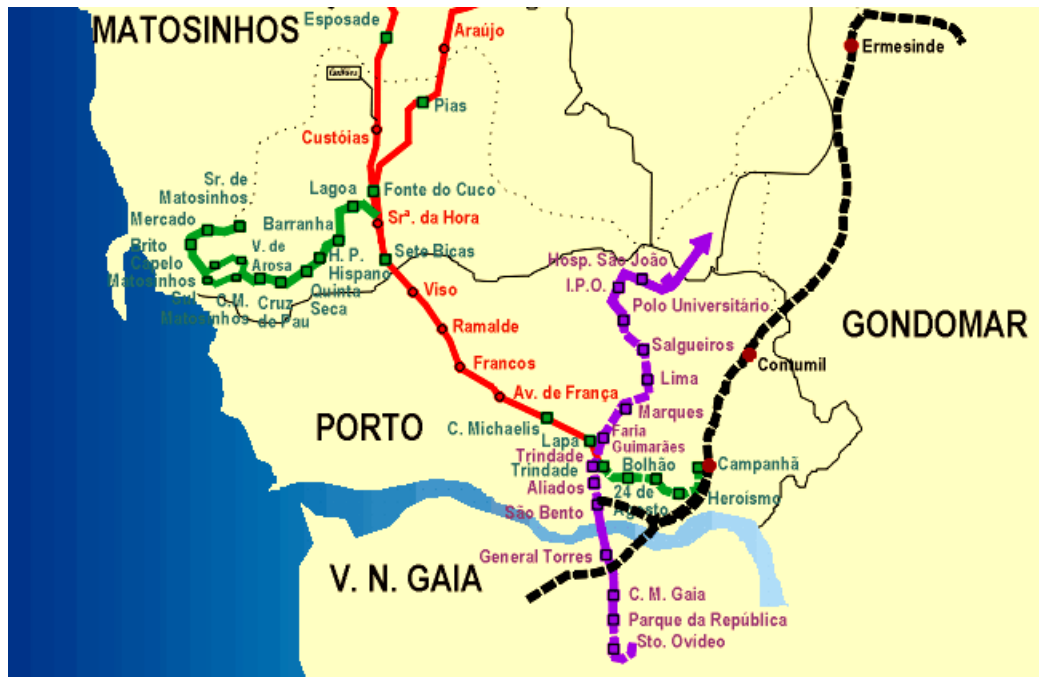
Figure 1: Map of Metro do Porto routes. Underground tunnels are Line C from Campanhã to Trindade and Line S from Salgueiros to São Bento.

In late 1998 the Municipality of Porto took a decision to upgrade its existing railway network to an integrated metropolitan transport system with 70 km of track and 66 stations. Seven kilometres of this track and 10 stations are located under the picturesque and densely populated city of Porto, a UNESCO world heritage site. A map of the surface and underground routes is presented in Figure 1.

The underground tunnel, driven by two Earth Pressure Balance (EPB) TBMs, has an internal diameter of 7.8 m and accommodates two tracks with trains running in opposite directions. Line C stretches 2,350 m from Campanhã to Trindade and has five underground stations, a maximum cover of 32 m and a minimum of 3m before reaching Trindade station. Line S is 3,950 m long and runs from Salgueiros to São Bento with 7 stations and a maximum overburden of 21 m.

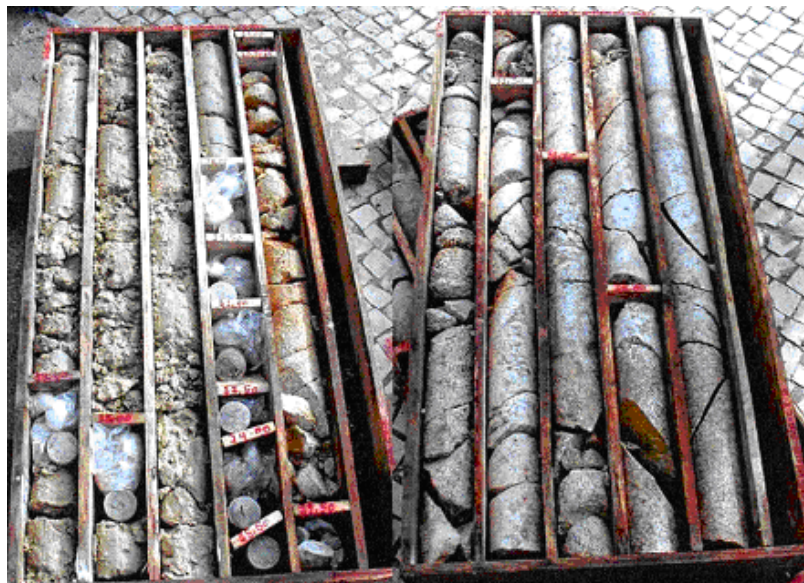
Figure 3: Appearance of different degrees of weathering in granite in a core recovered from a site investigation borehole on the tunnel alignment. Note that the weathered granite in the left box is at a depth of about 24m under the sound granite of the right box. This must therefore correspond to a huge boulder (core).

A particularly striking feature is that, due to the erratic weathering of the granite, weathered zones of considerable size can be found under zones of sound granite (see Figure 3). While this phenomenon is an exception rather than the rule and it was expected to disappear with depth, it could not be ignored in the zone intersected by the construction of the metro works. A typical case of such setting is in Heroismo station where weathered granite with floating cores of granite occurs under a surficial part of a sound granitic rock mass (Figure 5).

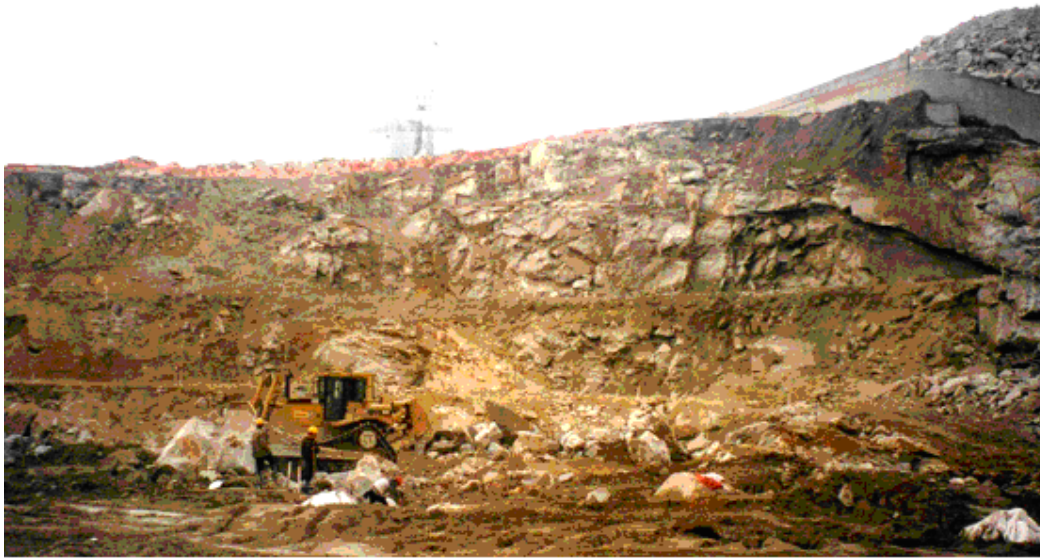
Figure 4: Appearance of Oporto granite in the face of an excavation for the new football stadium. Fracturing of the rock mass and heterogeneity of weathering is obvious

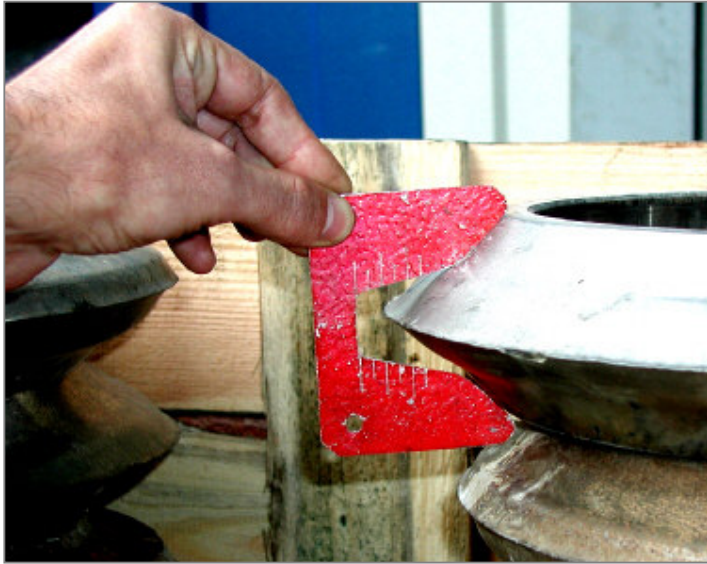
Figure 10: Typical wear of the disk cutter showing that the flanks of the disk are worn as quickly as the cutting surface.

The Oporto granite is a highly abrasive material and, when broken down into the conditioned paste in the working chamber of an EPB TBM, it becomes a very effective grinding paste. Even in the very weathered form, the final weathering product contains the skeleton minerals, mainly quartz, which characterise the dominant granular fraction. For example, The average percentage of secondary minerals in both the bulk weathered rock or the bulk saprolite is low ~2,5% and ~9% respectively (A. Begonha and M. A. Sequeira Braga, 2002) This keeps abrasiveness high and proved to be a major problem in Oporto where cutter wear necessitated frequent replacement of cutters. On average, one cutter was consumed per running metre of tunnel drive and, in addition, there was severe wear of the cutter head construction. These problems are illustrated in Figures 10 and 11.

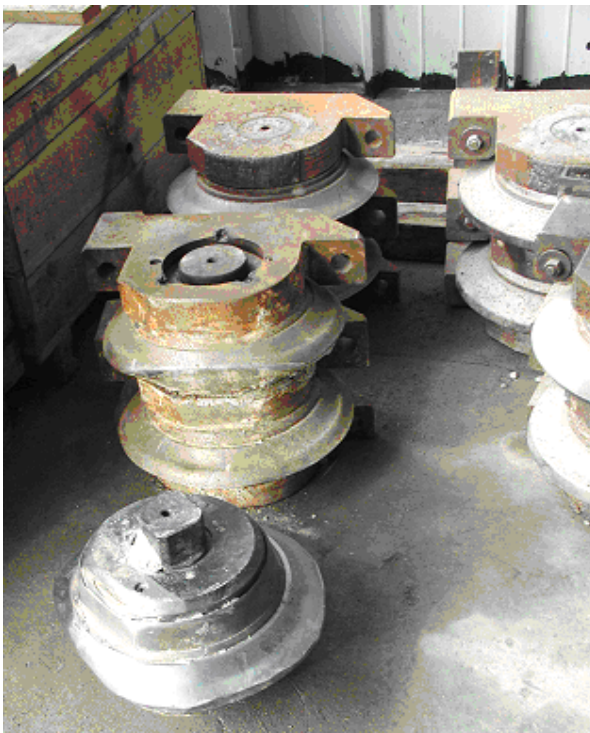
Figure 11: Wear of the disk cutter bearings and bearing mounts. Disks that do not rotate freely wear asymmetrically while freely rotating disks are abraded as shown in Figure 10.

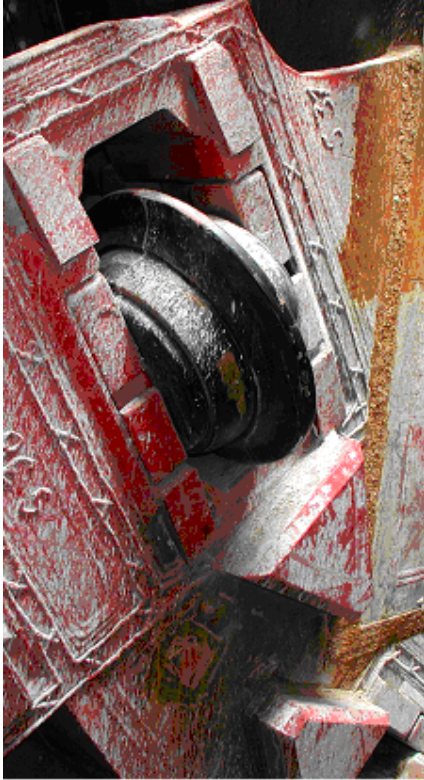
Figure 12: Addition of deflector wedges ahead of disk cutters helped to deflect paste from the bearing assembly.

Numerous trials were carried out with different conditioning agents in an attempt to reduce cutter wear but none of these proved to be of any great help and the cutter wear problem persisted until the end of the tunnel drives. Some relief from the bearings and bearing mounts was obtained by welding a deflector wedge ahead of the cutter assembly as shown in Figure 12.

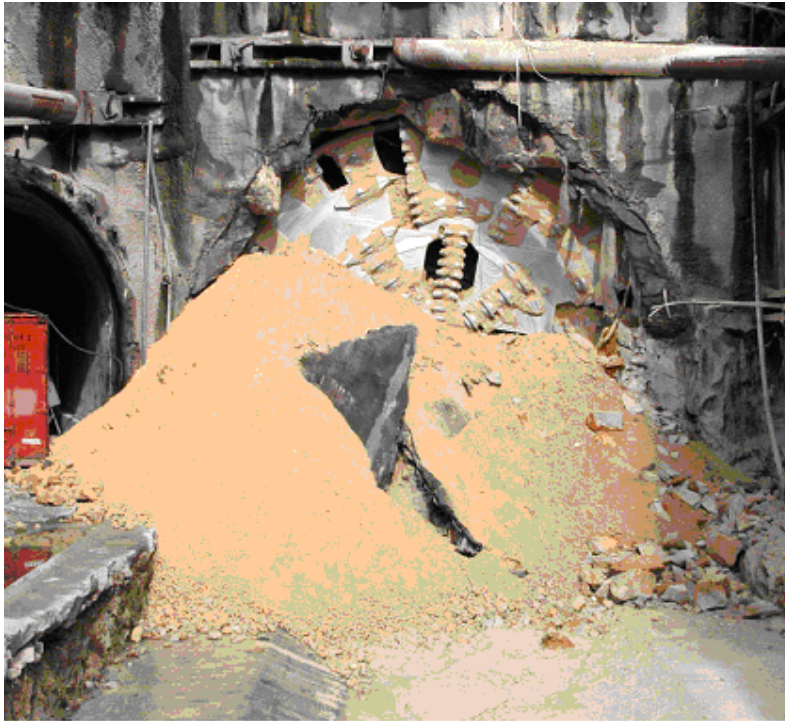
Figure 13: Final breakthrough of the TBM S-203 on the completion of the drive from Salgueiros to Trindade on Thursday 16 October 2003.

The final breakthrough of the C line drive is illustrated in Figure 13.
