Hoek, E and Guevara, R. 2009. **Overcoming squeezing in the Yacambú-Quibor tunnel, Venezuela.** *Rock Mechanics and Rock Engineering*, Vol. 42, No. 2, 389 - 418.

Overcoming squeezing in the Yacambú-Quibor tunnel, Venezuela

Abstract

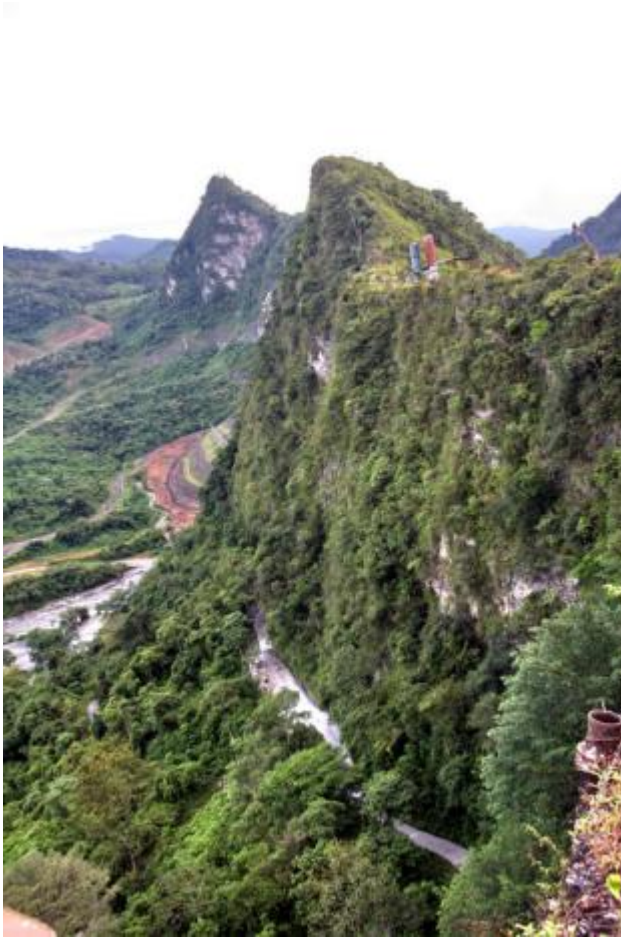
Figure 4: Downstream face of the ridge in which the Yacambú dam is located. The downstream toe of the concrete-faced rockfill dam can be seen in the centre of the photograph.

The original site investigations, dating back to the 1970s, involved walk-over surveys, core drilling and the construction of several exploration adits. Most of the drilling and the adits were concentrated in the silicified phyllite in the area of the Yacambú dam site where some of the exploration tunnels have stood, without any support, for more than 40 years. The strength of the silicified phyllite is exemplified in the steep sided canyon in which the 160 m high concrete faced rockfill dam is located and by the steep downstream face of this ridge, shown in Figure 4.

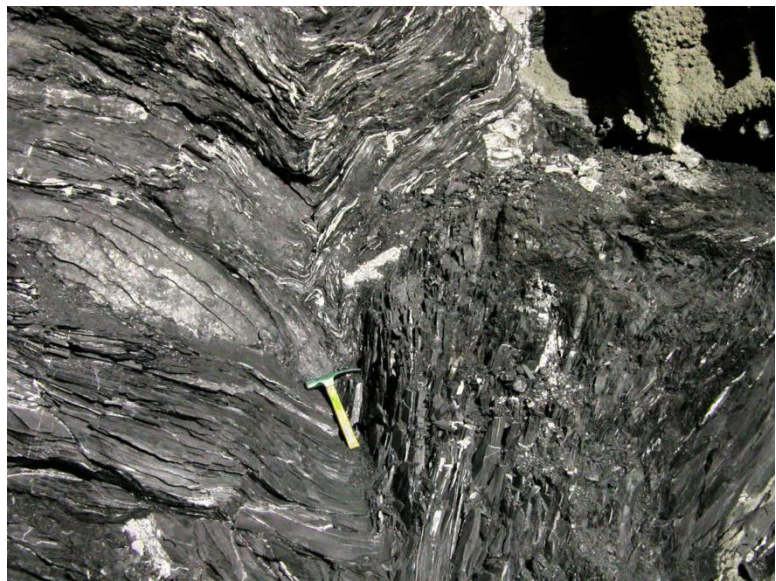
Figure 5: Tectonically deformed graphitic phyllite at the tunnel face.

A limited amount of drilling was done at the tunnel portals but only three vertical boreholes were attempted along the tunnel alignment. The deepest had to be abandoned at 300 m depth because of technical difficulties. Consequently, most of the detailed geology along the tunnel alignment was revealed as the tunnel was excavated and it turned out that, rather than the silicified phyllites anticipated on the basis of the dam site investigations, a high proportion of the rock consists of a highly tectonically deformed graphitic phyllite which behaves in a completely different way than the silicified phyllite. The appearance of the graphitic phyllite at the tunnel face is illustrated in Figure 5.

individual rock pieces when they are more or less randomly oriented in the rock mass, on the scale of the tunnel, as illustrated in Figure 5.

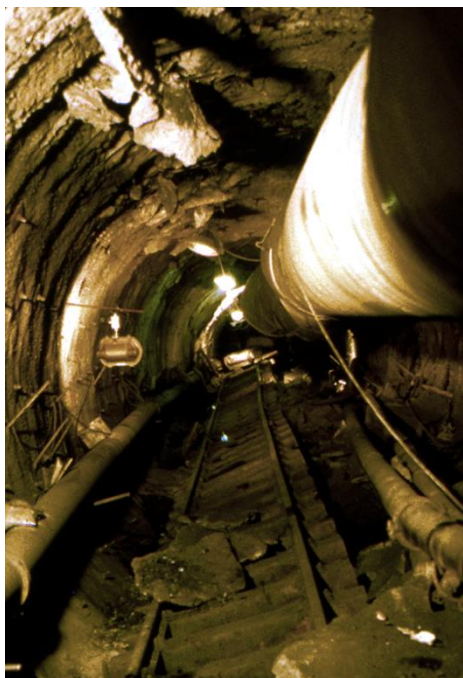
Figure 6: Floor heave about 100 m behind the Intake drive TBM in 1979 at a depth of 400 to 425 m below surface.

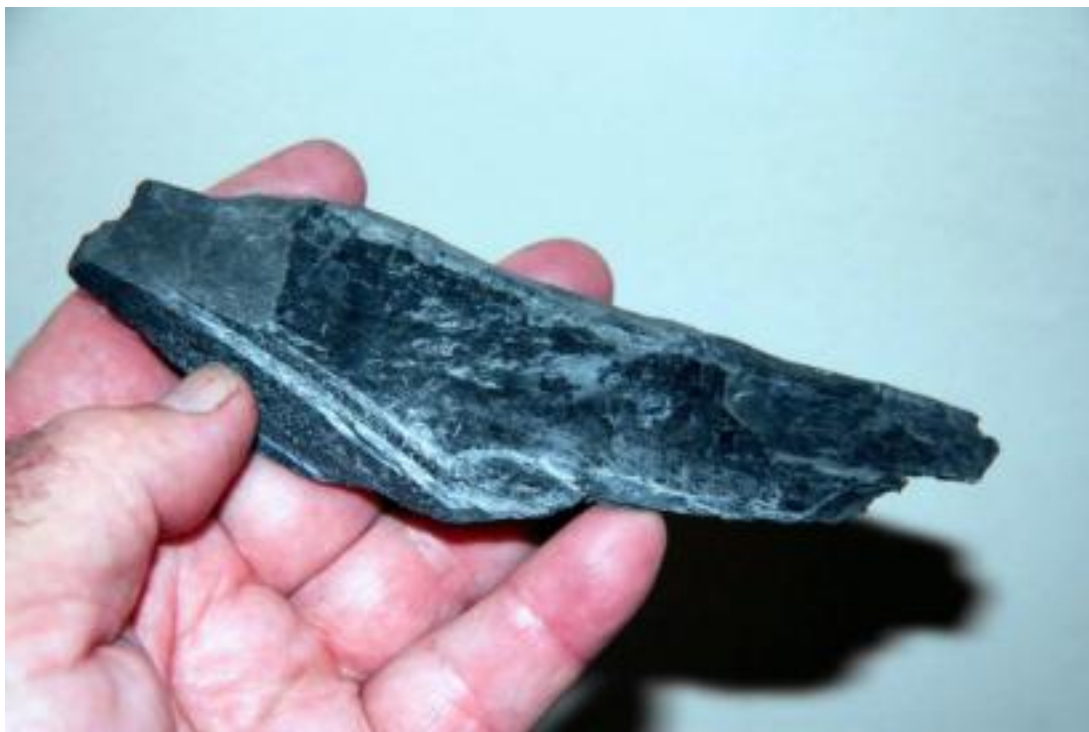
Figure 11: Intact sample of graphitic phyllite from Yacambú-Quibor.

A critical component of the rock mass strength determination in the Hoek-Brown failure criterion is the uniaxial compressive strength σ_{ci} of the intact pieces of rock that make up the rock mass. In the case of the graphitic phyllite encountered in the Yacambú-Quibor tunnel, it proved to be difficult to arrive at a consensus on how the strength should be estimated in the field. Most geologists on the project were inclined to assign very low values of 5 to 15 MPa on the basis of the poor appearance of the rock mass and the slickensided nature of the surfaces as illustrated in Figure 11. However, back analyses of the tunnel behaviour suggested that this value should be closer to 50 MPa. Uniaxial compressive tests on oriented specimens of a similar Venezuelan graphitic phyllite by Salcedo (1983) gave the results presented in Figure 12. A maximum UCS of approximately 100 MPa was found for specimens tested normal to schistosity while a minimum of approximately 15 MPa is given for tests on specimens with the schistosity inclined at about 30° to the loading direction. These results are typical for highly schistose rocks and it is not unreasonable to assume an average UCS of 50 MPa for the intact strength of the

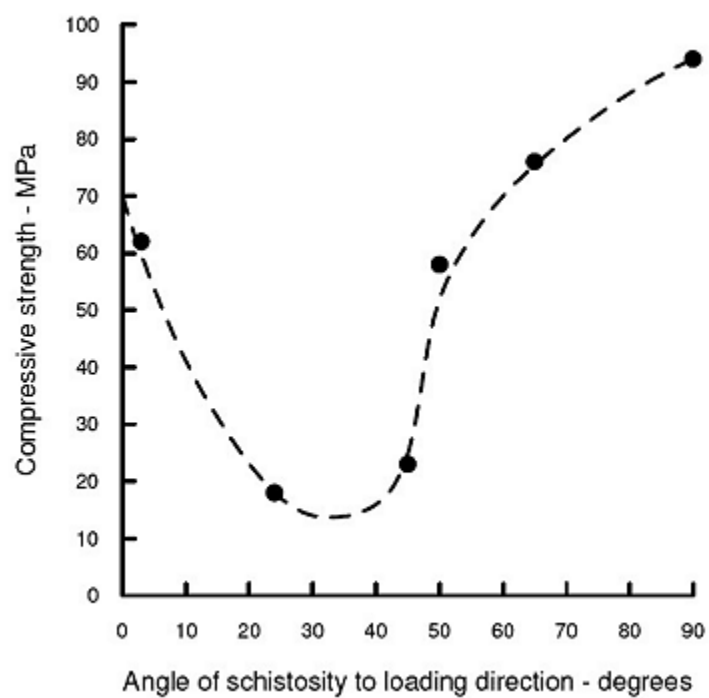
Figure 12: Anisotropic strength of a typical graphitic phyllite.

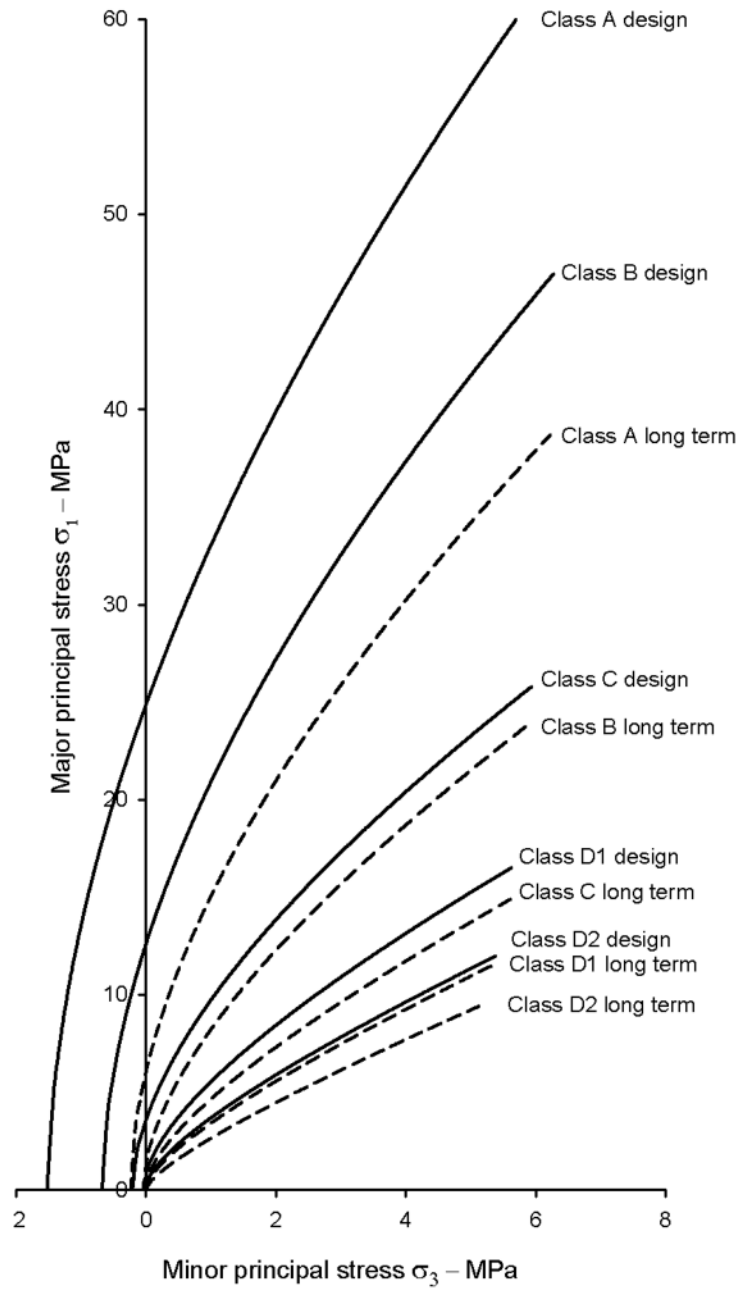
Figure 13: (a) Plot of major versus minor principal stresses for design and long term strength of the 5 rock classes listed in Table 2.

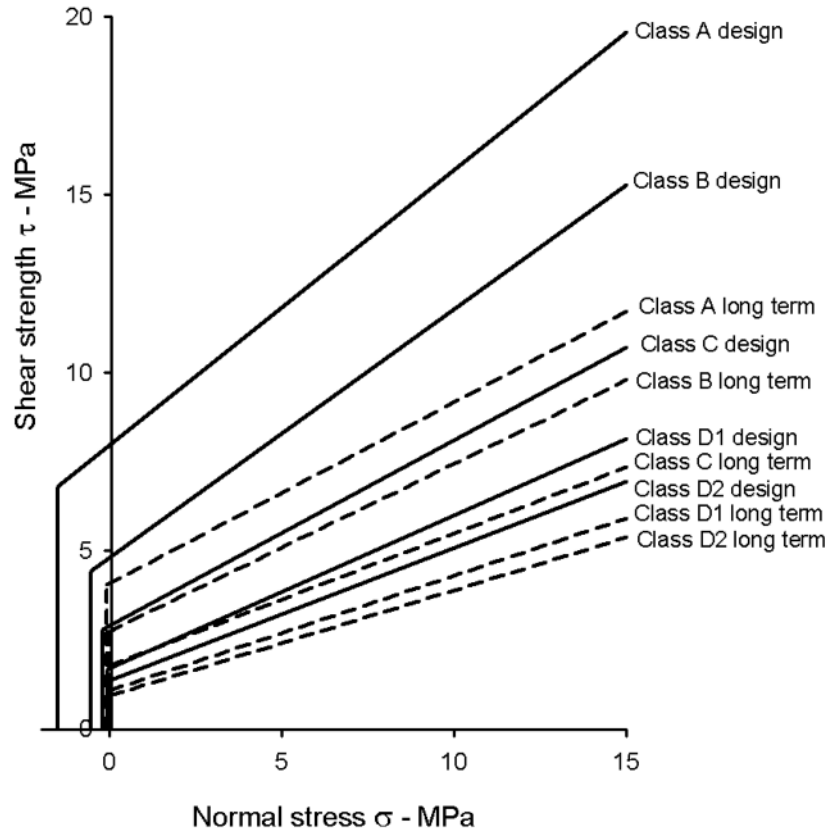
Figure 13 (b) Plot of linear shear strength envelopes (based on equivalent c and ϕ values) for the same rock types.

Many programs used for the analyses of tunnel behaviour accept input for the Generalised Hoek-Brown failure criterion (Hoek et al, 2002) thereby enabling the user to carry out progressive failure analysis in terms of the non-linear relationships illustrated in Figure 13(a). However, In order to present these analyses in a form that can be understood by readers who are not familiar with the Hoek-Brown criterion, equivalent Mohr-Coulomb strength parameters have been included in Table 2 and plotted in Figure 13(b).

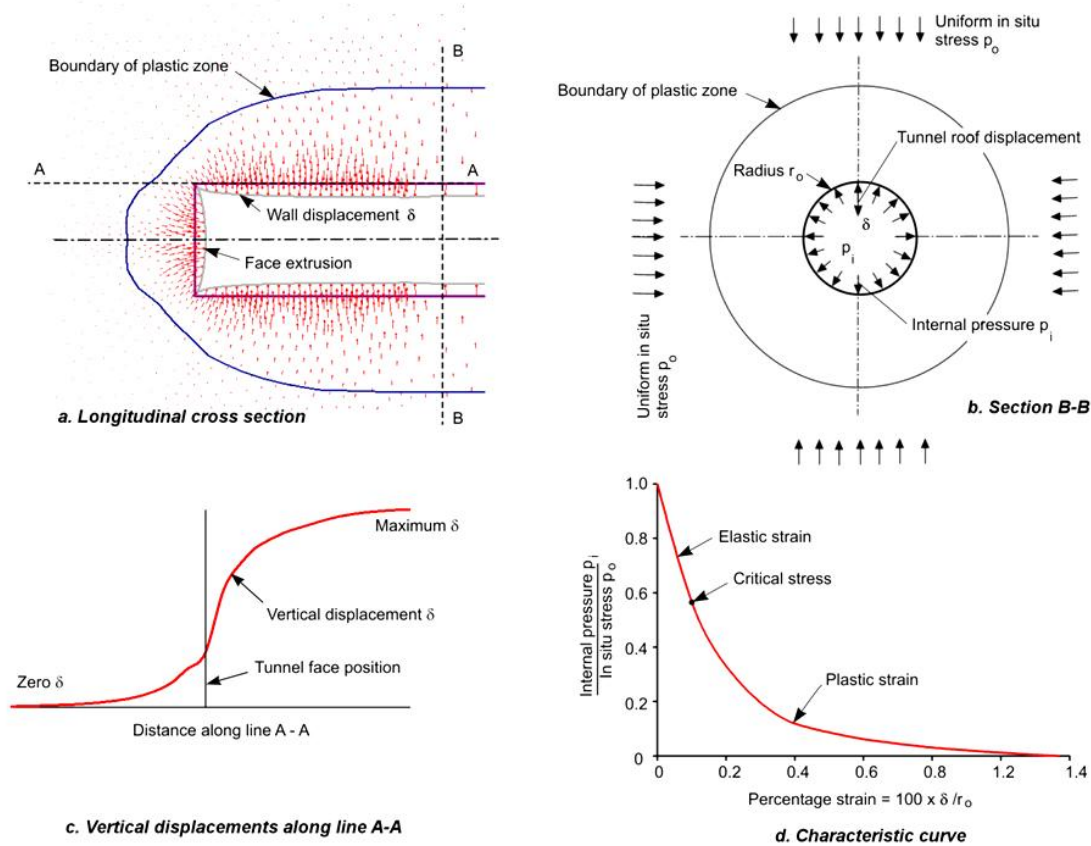
Figure 16: Development of a plastic zone and associated displacements as a tunnel advances through overstressed weak rock

When a tunnel is mined into a rock mass in which the stresses are high enough to induce failure, a zone of failed rock is formed around the tunnel. This zone, frequently referred to as the "plastic zone" is illustrated in the sections given in Figure 16 a and b.

In constructing this figure it is assumed that the tunnel is circular, the horizontal and vertical in situ stresses are equal and an internal pressure p_i acts inside the tunnel. It is also assumed that the response of the rock mass is instantaneous, i.e. time dependent behaviour of the rock mass surrounding the tunnel is not taken into consideration. This could be considered a serious deficiency in the analysis since practical observations of tunnelling in highly stressed ground confirm that there is almost always a strong time-dependency to the rock mass behaviour.

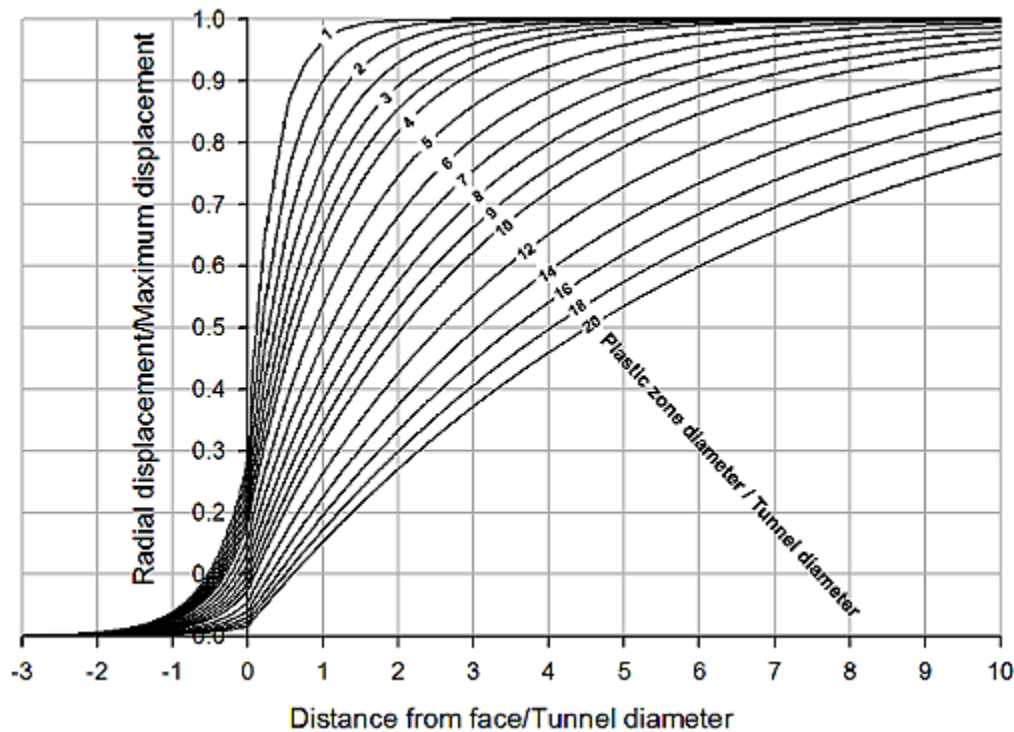
Figure 17: Longitudinal Displacement Profiles for different ratios of plastic zone to tunnel diameter.

The Longitudinal Displacement Profile depends upon the properties of the rock mass and the in situ stresses which, in turn, define the size of the plastic zone. Figure 17 shows the variation in the shape of this profile for different ratios of plastic zone to tunnel diameters (Vlachopoulos and Diederichs, 2009). These curves are important for determining the displacements at the tunnel face and at the time of support installation.

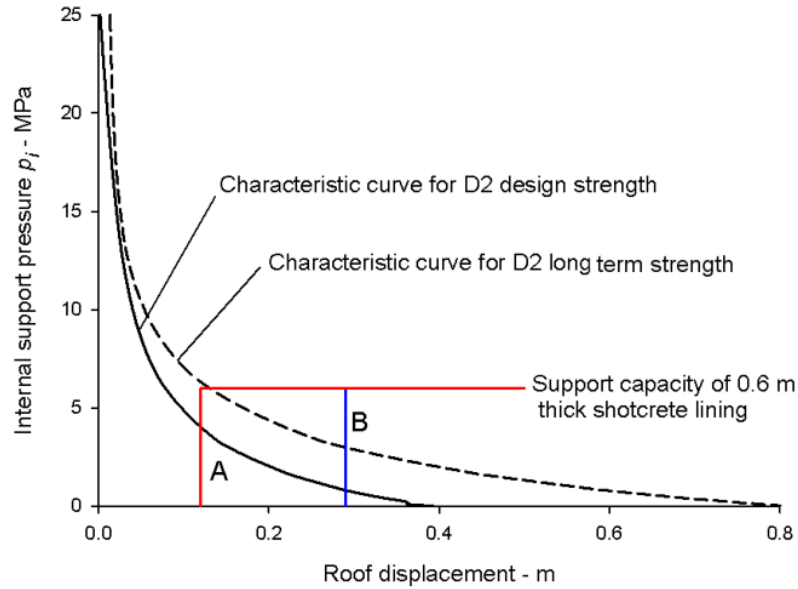
Figure 18: Characteristic curves for an unsupported tunnel in D2 rock mass at 1000 m depth.

Characteristic curves for both design and long term conditions are plotted in Figure 18. Note that, in calculating the characteristic curve for the long term condition, the long term rock mass properties have been applied to the plastic zone only since it is assumed that long term changes due to displacement induced damage, air and water circulation and the like will be restricted to this zone.

Line A in Figure 18 intersects the characteristic line for the design strength at approximately 4 MPa and this represents the support capacity mobilised at the time of installation. Since the capacity of the lining is 5.5 MPa (ignoring the reduced strength of uncured shotcrete for the moment), the factor of safety is given by the ratio of available capacity to mobilised capacity and this is 1.5. However, the available capacity is lower than that required for long term conditions (dashed characteristic curve in Figure 18) and the lining will be overstressed.

An obvious solution to this problem is to delay the installation of the lining and, following the same procedure as used above, lines B in Figures 19 and 18 show the installation of the lining at a distance of 15 m behind the face. In this case the short term (design) factor of safety is approximately 5 while, for the long term conditions, the available lining capacity is approximately twice the required capacity.

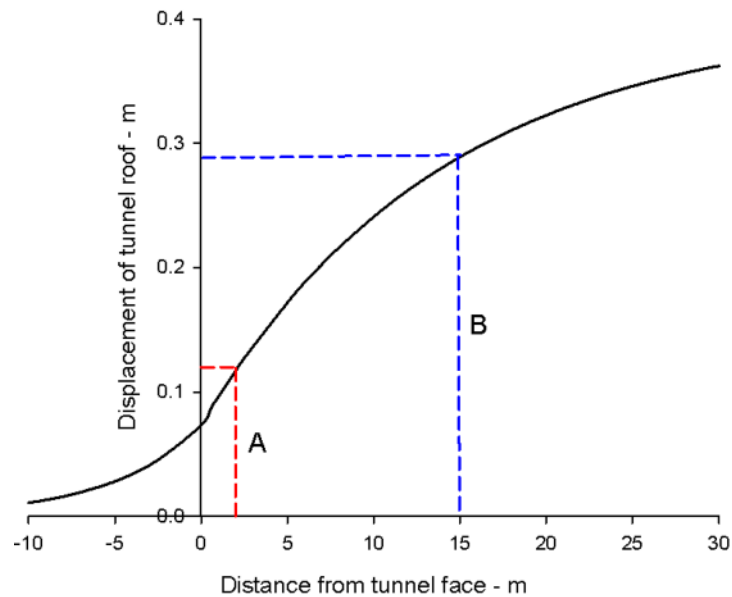
Figure 19: Longitudinal displacement plot for the design conditions in D2 rock.

The radius of the plastic zone for the fully excavated unsupported tunnel for the D2 design strength conditions was found to be approximately 10.4 m. Figure 19 gives a plot of the Longitudinal Displacement Profile for this set of conditions, for a ratio of plastic zone to tunnel radius of $10.4/2.6 = 4$. This curve was calculated from the data used in constructing Figure 17, tabulated in Appendix 1.

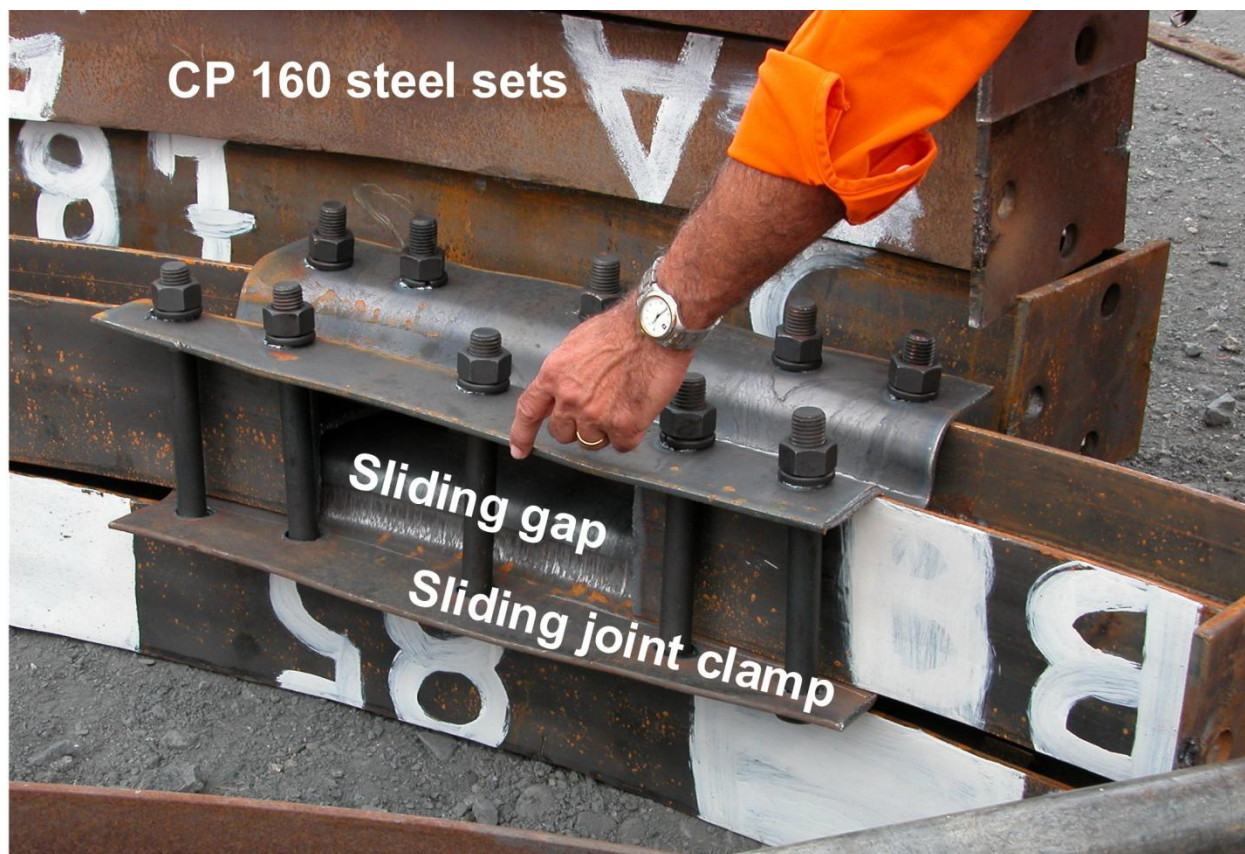
Figure 22: Details of one of the two sliding joints in the steel sets.

In the case of the Yacambú tunnel several yielding support systems were investigated during the early 1990s and the design finally adopted is illustrated in Figures 21 to 24. The design of this system was based on the requirements that it could be constructed on site from readily available locally manufactured steel sections, it had to be easy to assemble in the limited space available at the tunnel heading and it had to provide sufficient capacity to protect the workmen in the event of a sudden convergence of the tunnel.

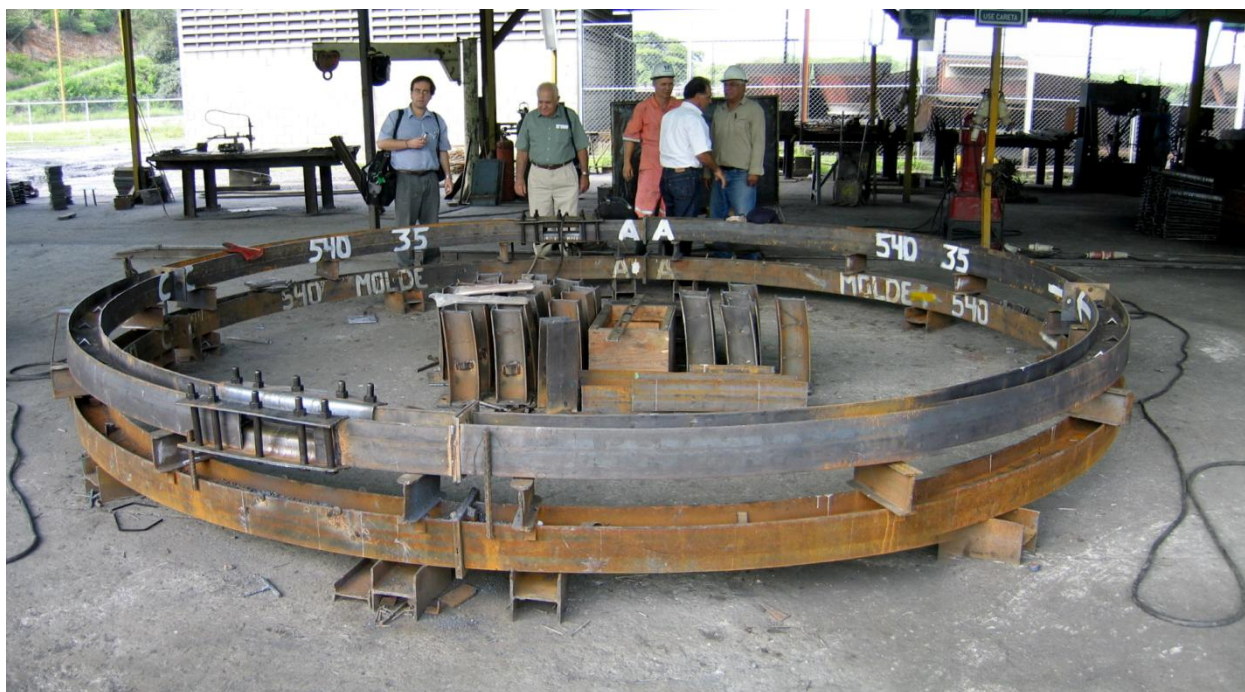
Figure 23: Assembled steel set with two sliding joints in the site workshop.

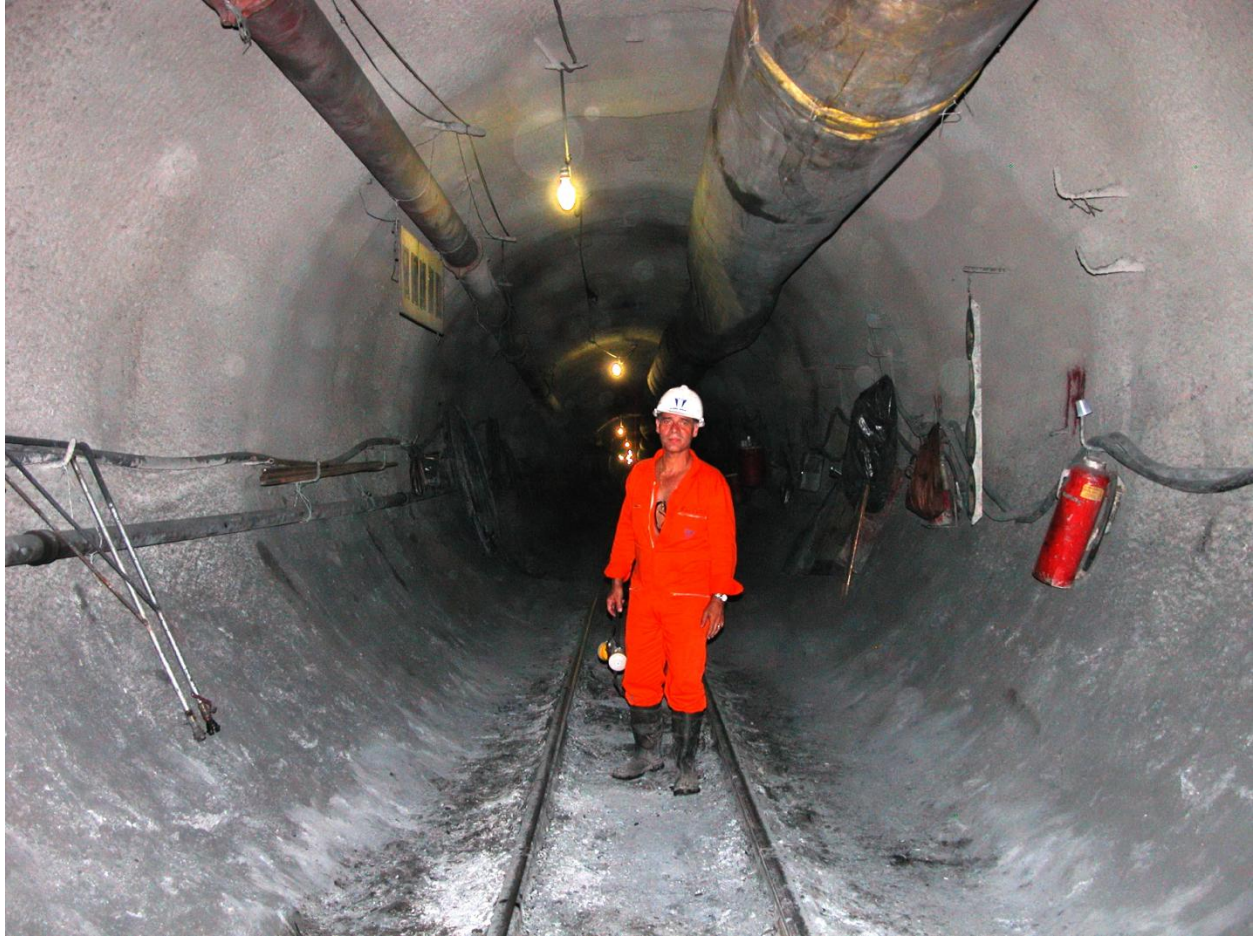
Figure 25: Completed tunnel lining in one of the deepest sections between Chainages 10000 and 12000.

Placing of the steel sets, generally at a spacing of 1 m, was followed by the immediate application of a 20 cm thick layer of shotcrete. This was sufficient to embed the 16 cm deep sets and to form a protective shell above the workers. A 1 m wide window was left on both sides of the shotcrete shell to allow the sliding joints to move freely. This window was closed when the sliding gaps had closed or at a distance of about 15 m behind the face, whether or not the gaps had closed. Once the windows had been closed and the initial shell had been fully mobilized, a second inner shotcrete layer of up to 40 cm thick was placed to complete the lining. The appearance of the completed tunnel is shown in Figure 25.

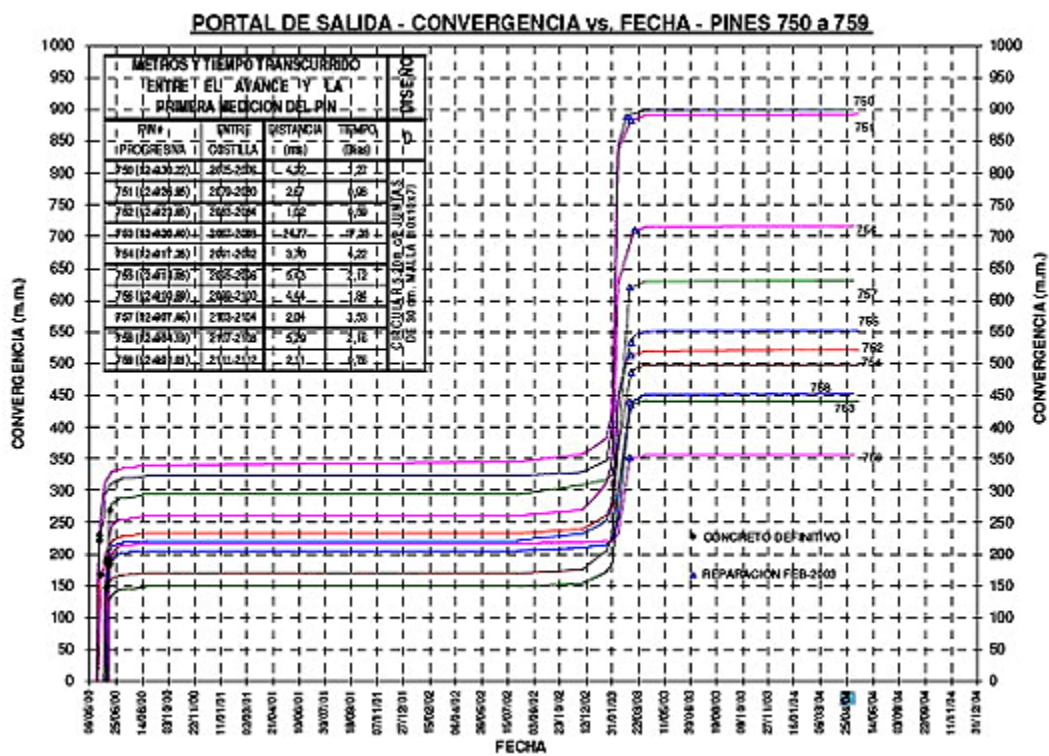
Figure 27: Extensometer measurements in the section between Chainage 12750 and 12850.

After about 2 years of service the extensometers registered a sudden increase in deformation as illustrated in Figure 27. This was followed by progressive deterioration and eventual collapse of the lining as illustrated in Figure 28.

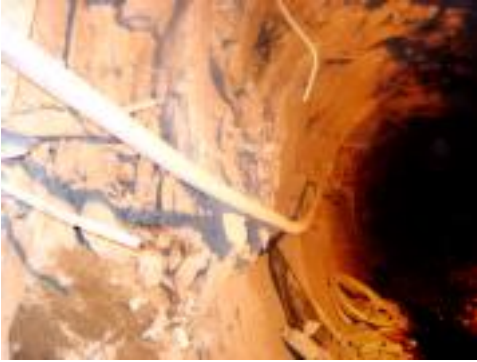
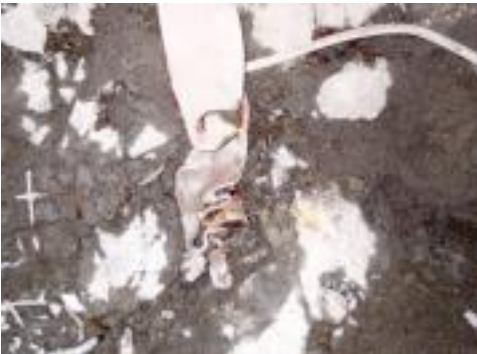
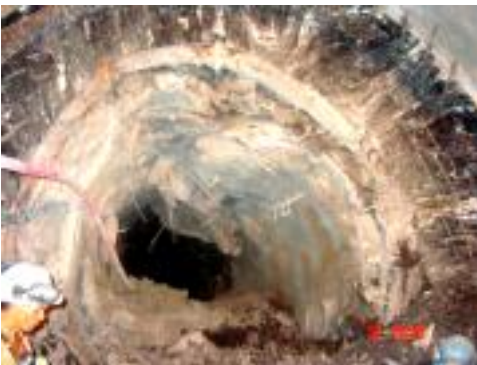
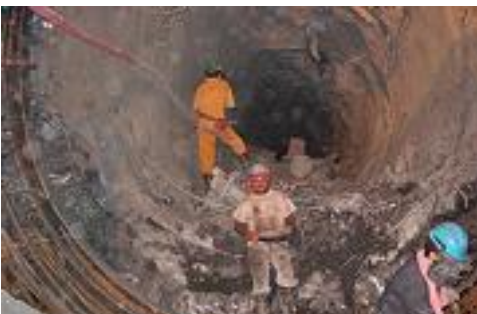
Figure 28: Evolution of the damage between Chainage 12+750 and 12+850. (Reproduced from Guevara et al, 2004.)

Initial damage with cracking of the shotcrete and loss of alignment of the track.

After removal of the cracked shotcrete, significant deformation of the WF 6 X 20 steel ribs could be observed.

In spite of having placed rings of rockbolts to isolate the damaged section, failure propagated to the roof of the section after removal of the damaged shotcrete in the invert.

As the failure developed, with closures of up to 1 m being observed, it was decided to re-mine the tunnel and replace the lining. The photograph shows a repaired section of the tunnel in the foreground and the damaged tunnel in the background.

With the gradual deterioration of the rock mass in the plastic zone surrounding the tunnel, the axial load on the steel ribs increases. For the assumed conditions in which the long term rock mass strength is used and the factor of safety of the steel ribs is reduced to approximately 0.8. Obviously, considering the variability of the rock mass and the loading conditions, failure of some sections of the lining are possible for the conditions illustrated in Figure 28.

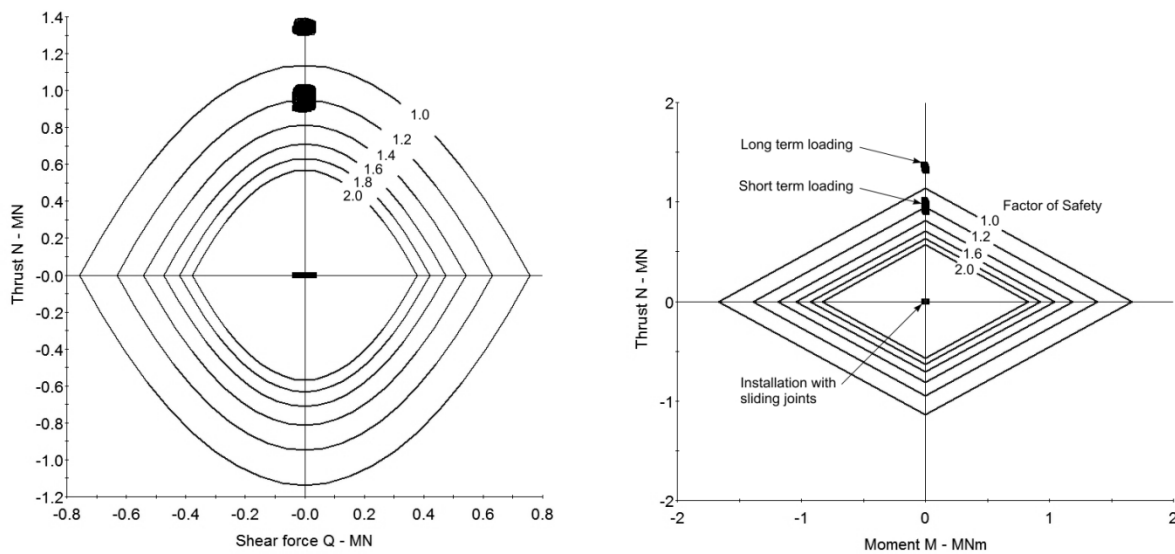
Figure 29: Support capacity plots for steel sets installed without shotcrete.

The support capacity curves for the steel ribs are shown in Figure 29. No load is carried at the time of installation since the joints are assumed to slide without resistance. A high axial thrust is induced after closure of the joints and at the end of the construction stage. This short term loading condition results in a factor of safety of approximately 1.2 for the steel ribs.

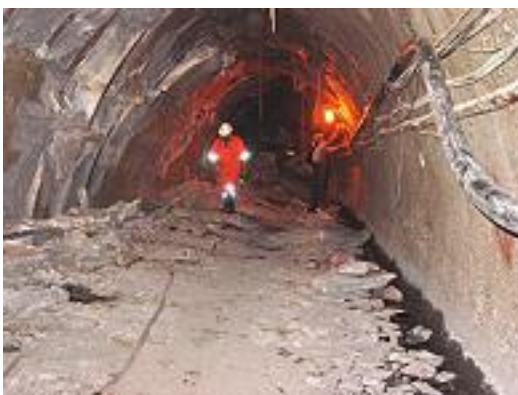
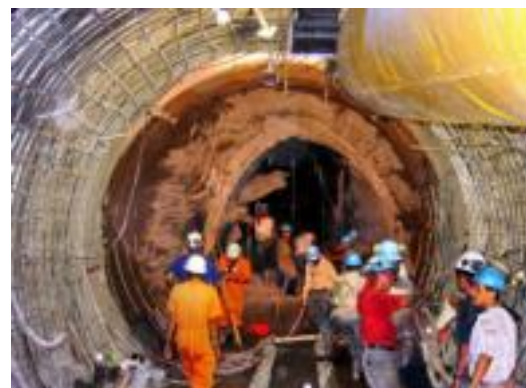
Figure 32: Initiation of failure and final rehabilitation of the tunnel at Chainage 2100.

a. Damage to invert and arch

b. Rehabilitation of collapsed tunnel

Failure of the installed support commenced approximately 10 years after construction with progressive deterioration of the invert, followed by overstressing of the steel ribs and shotcrete forming the arch. This failure is illustrated in the photograph reproduced in Figure 32 a. The second photograph (Figure 32 b) shows the final collapse of the tunnel and the rehabilitation work in progress.

Rehabilitation of the tunnel in this section was carried out by re-mining the collapsed tunnel in sections, as shown in Figure 32b, and installing the lining shown in Figure 36. This lining consists of a 50 cm thick shotcrete shell with reinforcement in the form of two layers of weldmesh. Since a large amount of deformation was associated with failure of the original tunnel, the load carried by the replacement lining is relatively low and there is no need to reanalyse the capacity of this new lining.
