Introduction

During this review, a rock slope on Sau Mau Ping Road in Kowloon was identified as being potentially unstable. The stability of this particular slope was critical because it was located immediately across the road from two blocks of apartments, each housing approximately 5,000 people.

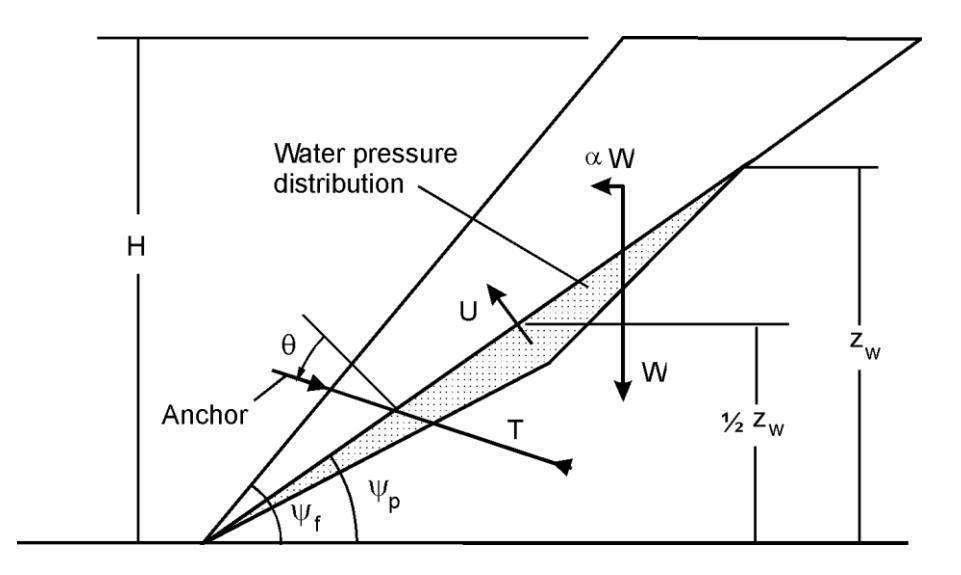
Figure 6: Factor of Safety calculation for a slope with no tension crack.

At the time of this investigation, no rock mechanics facilities existed in Hong Kong and no diamond drilling or laboratory testing had ever been carried out on the granitic rocks in which this slope had been excavated. Consequently, the problem was tackled on the basis of a crude form of risk analysis, using simple analytical models to predict the response of the slope to a range of possible conditions. The two models are defined in Figure 6 and Figure 7.

The traditional method of incorporating the acceleration induced by earthquakes or large blasts in slope stability analyses is to add an outward force αW to the forces acting on the slope (see Figure 6 and Figure 7), where α is the acceleration as a proportion of g, the acceleration due to gravity. This 'pseudo-static' form of analysis is known to be very conservative but, in the case of the Sau Mau Ping slope, this conservatism was not considered to be out of place.

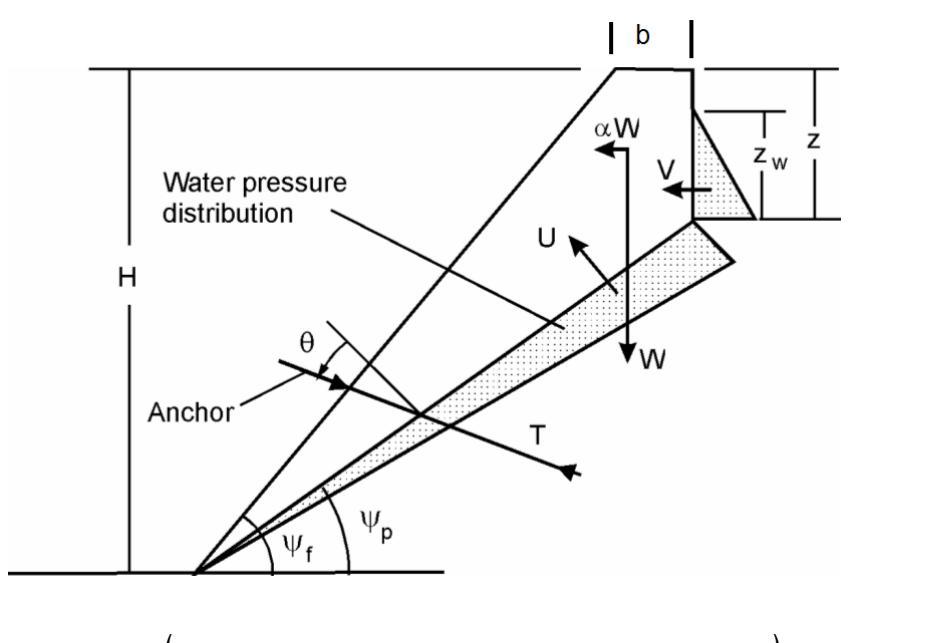
Figure 7: Factor of Safety calculation for a slope with a water-filled tension crack.

In Figure 7 the depth z of the tension crack is calculated by equation 6. This equation is obtained by minimising equation 5 with respect to the tension crack depth z (Hoek and Bray, 1974). This minimisation is carried out for a dry slope and the accuracy of equation 6 decreases as the water depth in the tension crack increases. However, for the purposes of this analysis, the estimate given by equation 6 is considered acceptable.

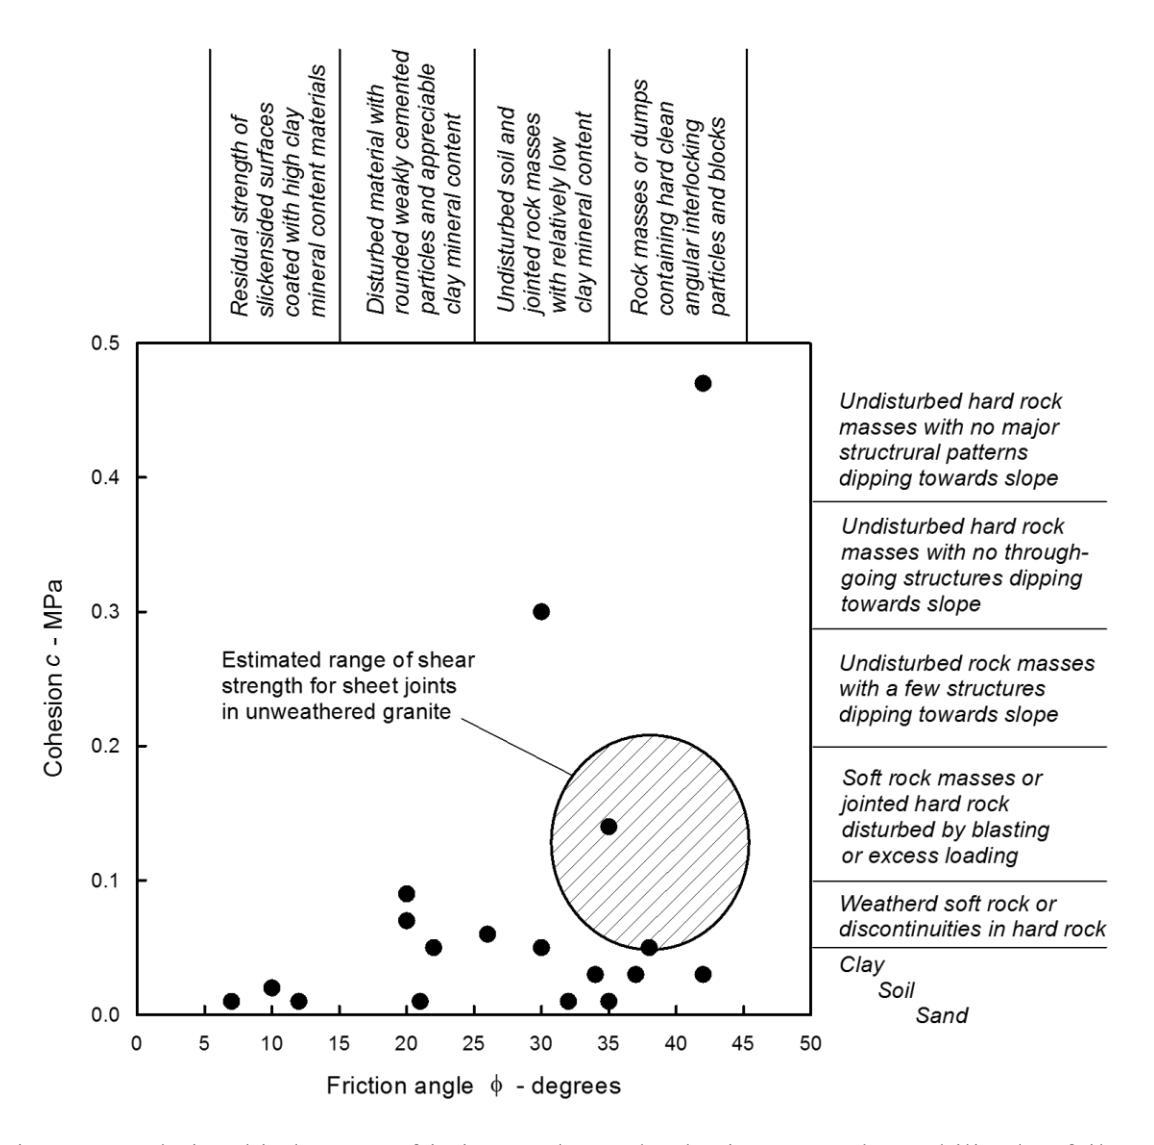
Hoek and Bray (1974) published a plot, reproduced in Figure 8, of cohesive strengths and friction angles for rocks and soils, based upon the results of published back analysis of slope failures. Superimposed on this plot is an elliptical zone which encompasses the estimated range of shear strength for sheet joints in unweathered granite. In choosing this range it was considered that the friction angle ϕ probably ranges from 30° for very smooth planar surfaces to 45° for rough or partly cemented surfaces. The cohesive strength c is more difficult to estimate and the range of 0.05 to 0.2 MPa was chosen on the basis of the results of back-analyses of slope failures, plotted in Figure 8.

Figure 8: Relationship between friction angles and cohesive strengths mobilised at failure of slopes in various materials. The plotted points were obtained from published information from the back analysis of slope failures. (After Hoek and Bray 1974).
